**ALOHA STADIUM**  
**Structural and Safety Evaluations:**  
**Weathering Steel and Decking Corrosion Assessment**  
DAGS Job No. 12-10-0651  
99-500 Salt Lake Boulevard  
Halawa, Honolulu County, Hawaii

**Final Report**  
December 12, 2018  
WJE No. 2014.6720.1

### **Weathering Steel and Decking Corrosion Assessment**

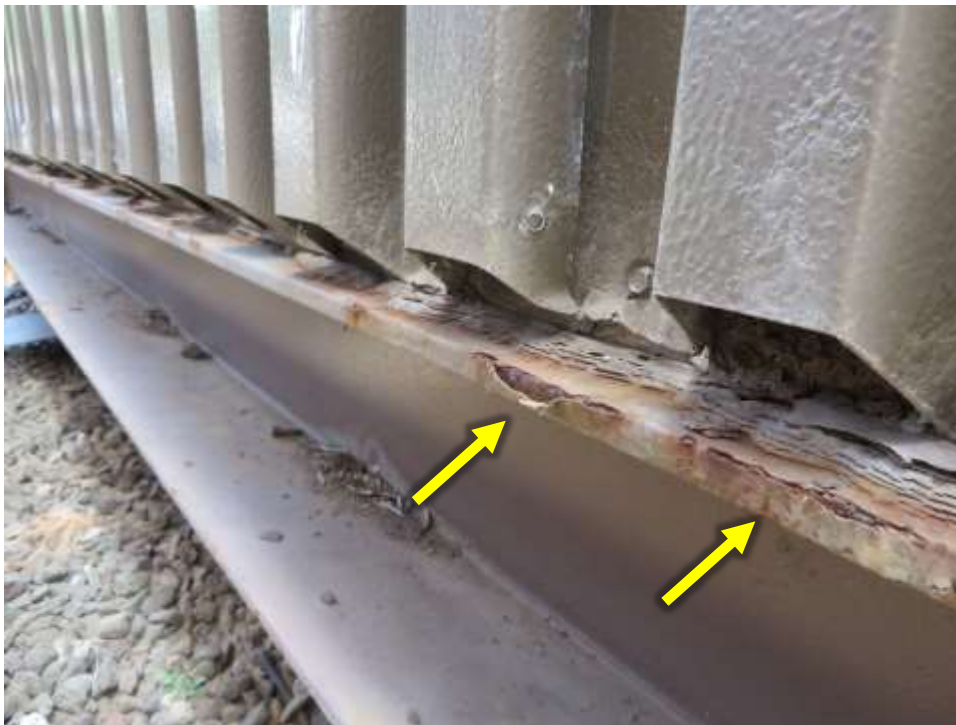
*Figure 10. Example of structural steel member classified as Condition State 3.*

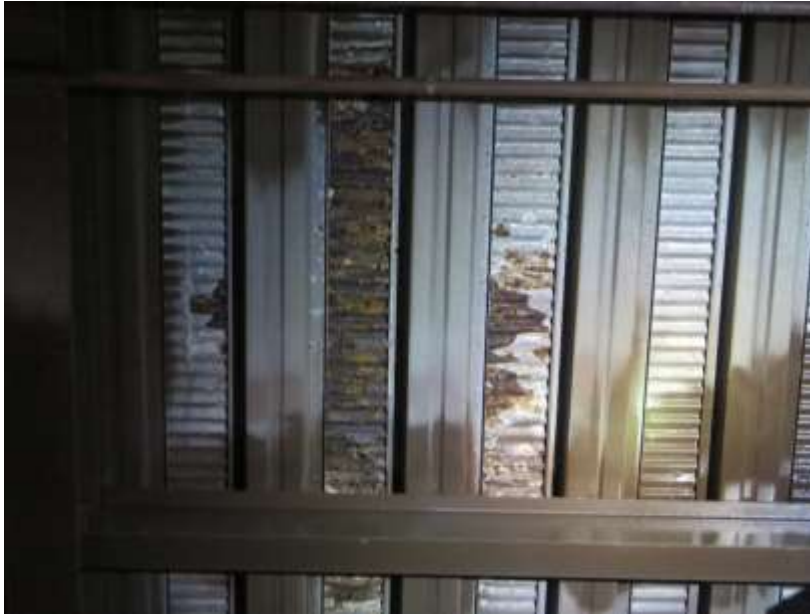
*Figure 11. Example of lightweight floor slab decking classified as Condition State 3.*

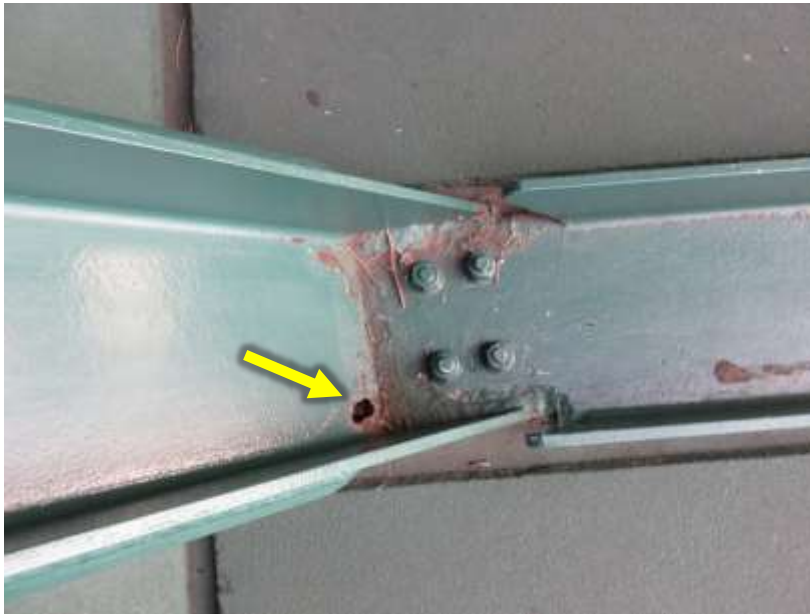
*Figure 12. Example of structural steel member classified as Condition State 4. The yellow arrow points to a hole completely corroded through the thickness of the web of the steel member.*

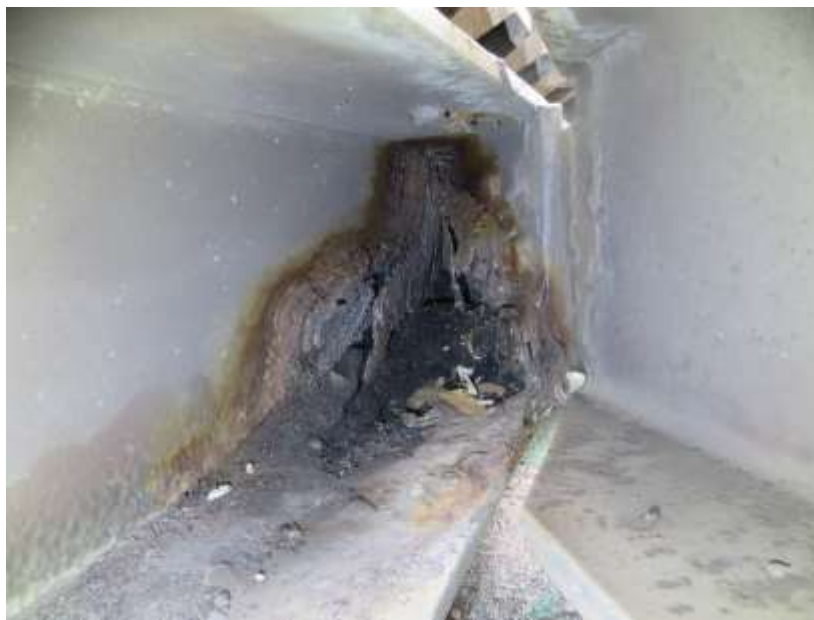
*Figure 13. Additional example of structural steel member classified as Condition State 4.*

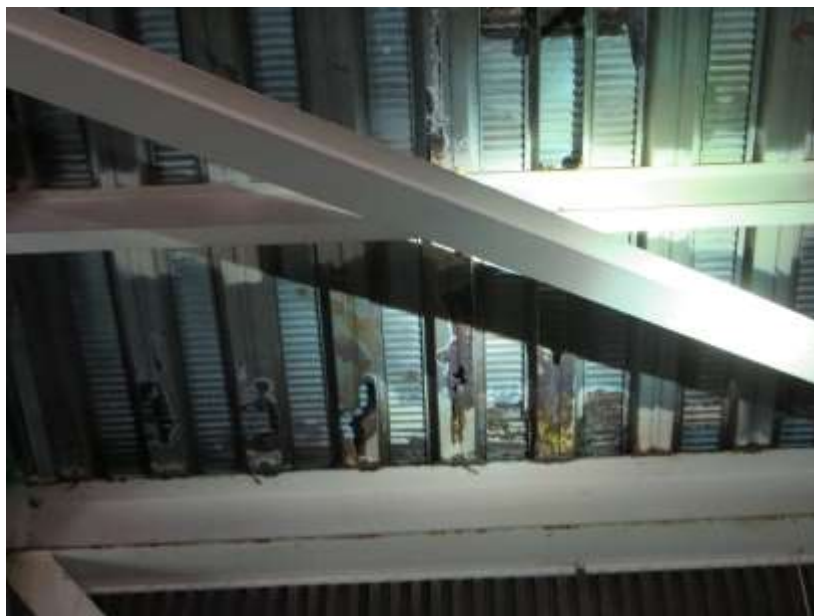
*Figure 14. Example of lightweight floor slab decking classified as Condition State 4.*

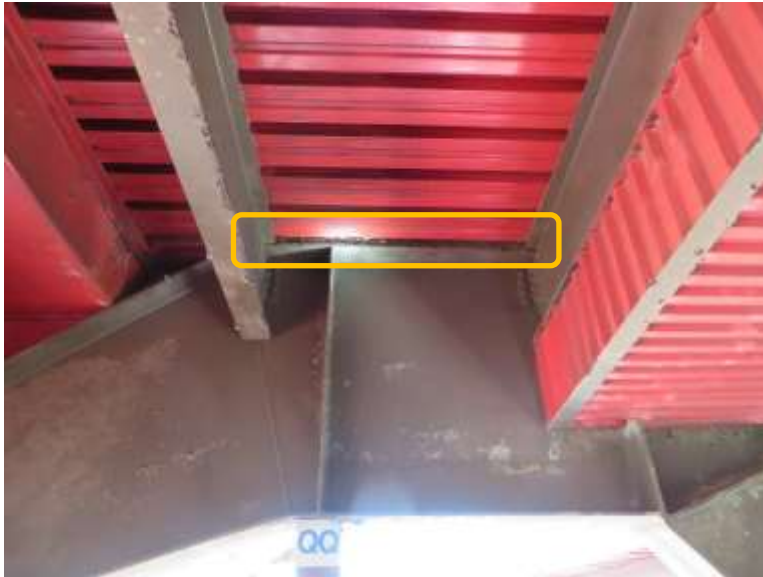
It appears that, over the years, rainwater has entered into operable access hatches in the floor deck at the ends of the cross aisles servicing the Red and Brown seating areas. The access hatches are located immediately above the subject raker beams in the end raker frames. The rainwater appears to have leaked directly onto the top flanges of the raker beams, resulting in notable corrosion to the top flanges of the raker beams due to relatively persistent wetness.

*Figure 16. Corroding top flange of deep raker beam supporting the Red seating area. This location is in an end frame of the northeast sideline stands. The deep beam is one component of the cantilever raker assembly that supports the Red and Brown seating areas.*

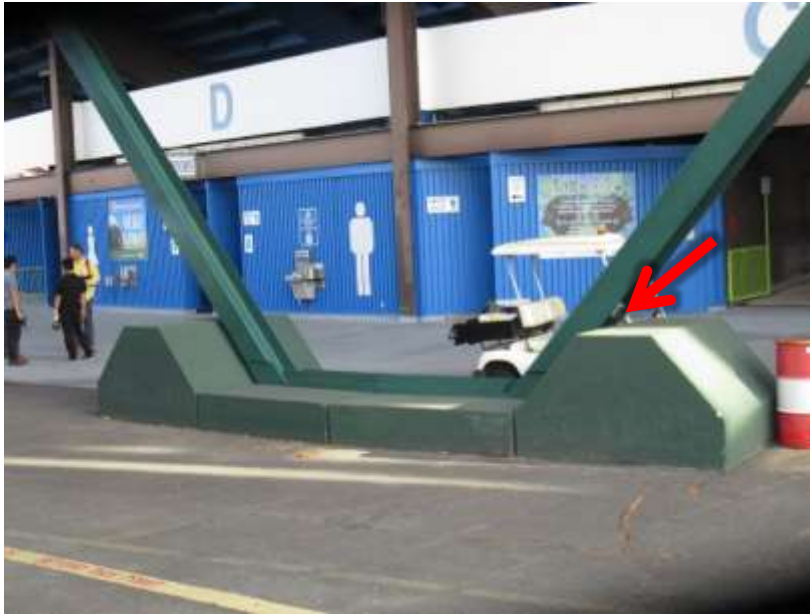
*Figure 17. Representative concrete barrier at base of structural steel braces that make up the diagonal bracing frame at the rear of the endzone seating stands (South endzone shown). The red arrow indicates viewing position for the photo of Figure 18.*

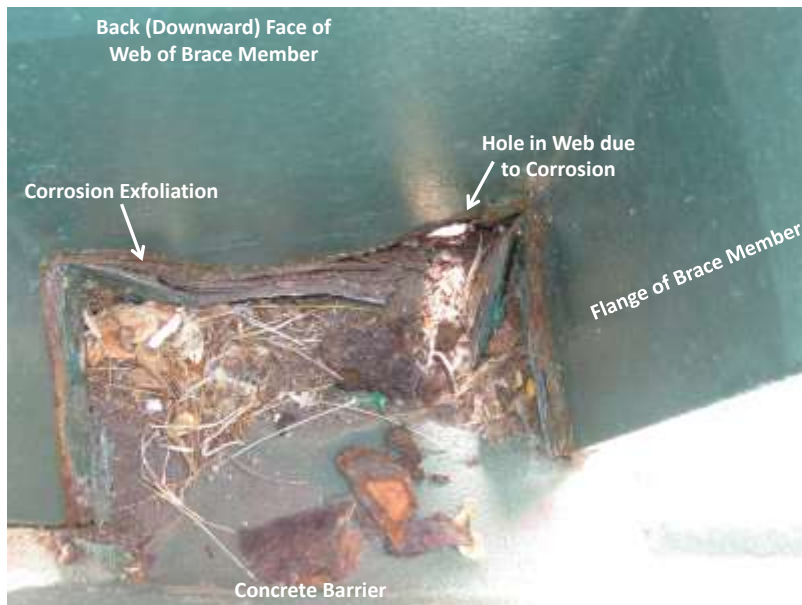
Based on our field measurements and subsequent structural analyses, we find that the current structural capacities of the as-corroded brace members are such that demand-to-capacity ratios are only slightly below 1.0. This means that the remaining structural capacity of the as-corroded brace member only marginally satisfies the structural strength requirements of the current building code.

*Figure 18. Annotated photo showing severe corrosion conditions at base connection of steel brace member to the concrete barrier (South endzone).*

In any event, the affected braces in the endzone seating stands will almost certainly continue to corrode, and if repairs are not implemented to mitigate the effects of corrosion and to restore structural capacities, the remaining structural capacities of the corroding endzone brace members will almost certainly be reduced to less than the structural capacities required by the building code. As summarized later in this report, it is recommended that the affected endzone braces be structurally repaired commencing immediately.

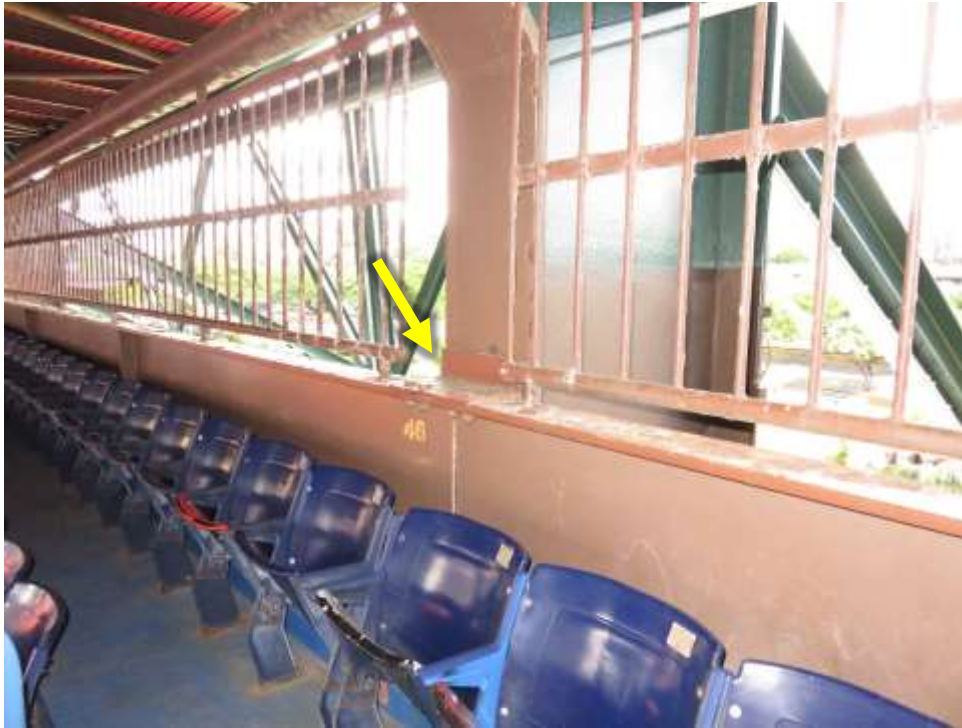
Water becomes entrapped between the vertical leg of the angle and flange of the raker column. The entrapped moisture is causing corrosion on the connection angle and the flange of the raker column. The expansion of the corrosion products between the connection angle and the flange of the raker column applies a prying force to the connecting pieces that has resulted in partial or complete failure of the weld between the connection angle and the raker column flange at many of these connections (Figure 20 and Figure 21). Continued corrosion at these connections will result in further cracking of the affected welds. At the time of our survey, the welds have failed to various degrees at approximately 75 percent of these angle connections.

*Figure 19. Typical location of problematic Blue seating section connection between girder and raker frame column.*

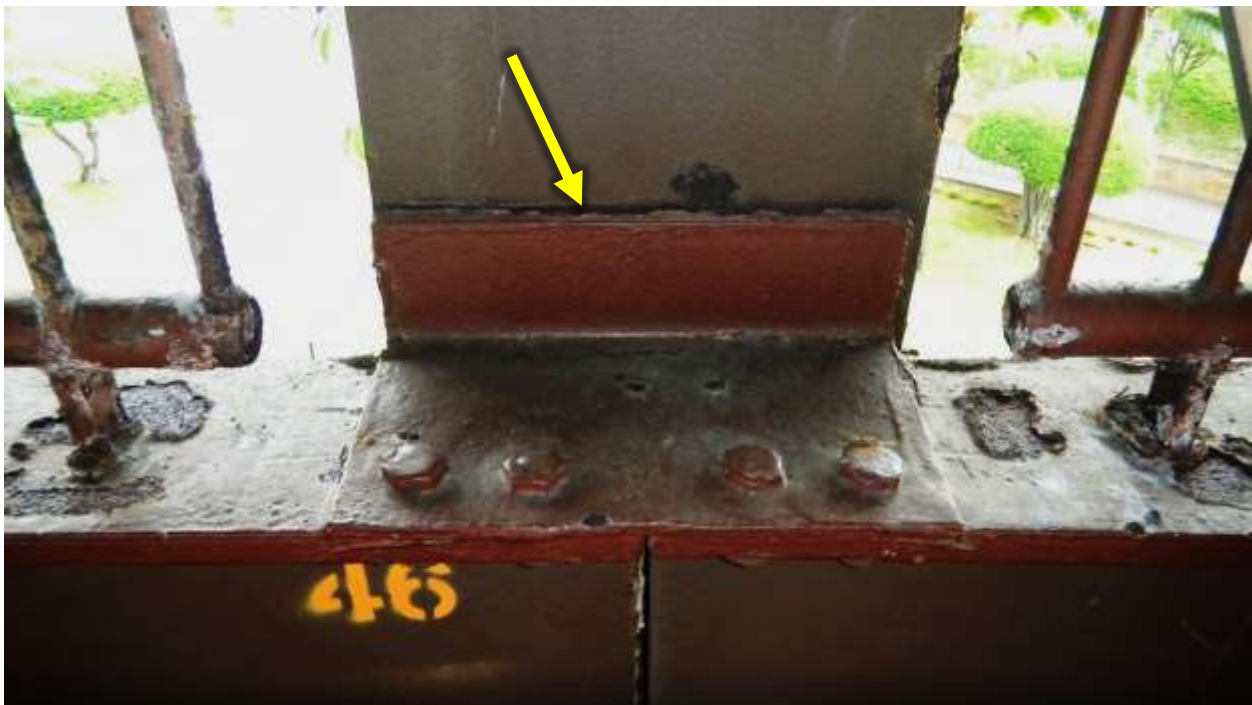
*Figure 20. The indicated weld line between connection angle and raker column flange has completely fractured.*

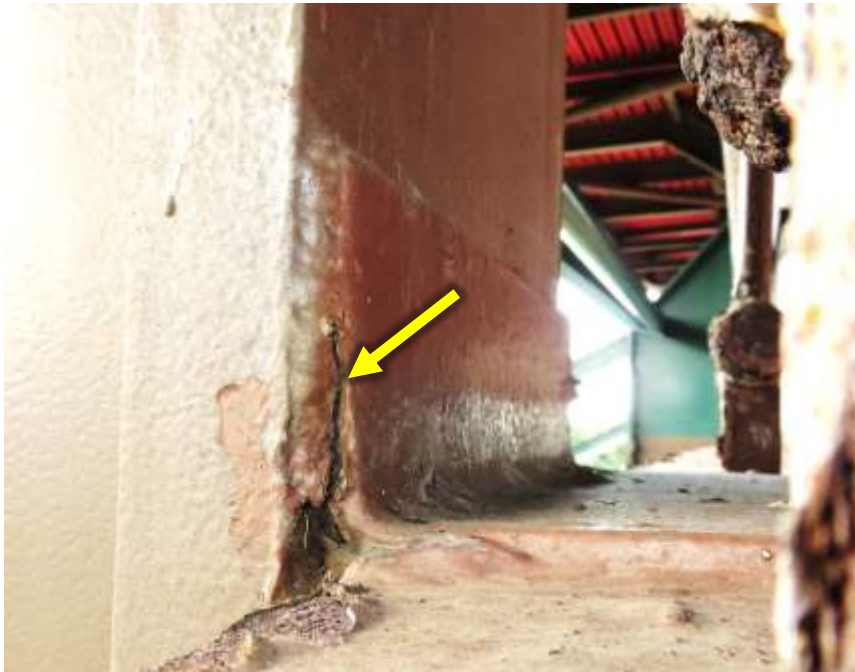
*Figure 21. The weld between the connection angle and raker column flange at this location has partially fractured.*

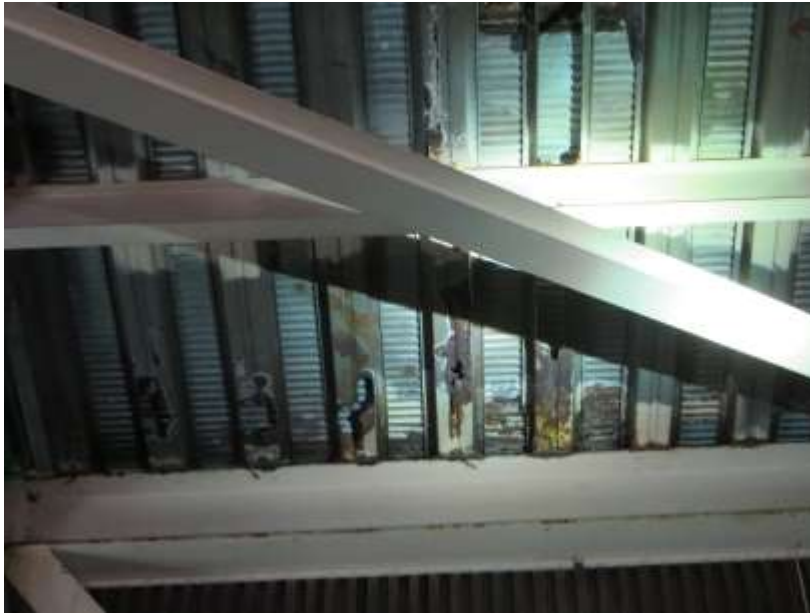
*Figure 22. Representative severe (CS4) corrosion conditions observed in decking and hat-channel sub-decking of the lightweight floor system of the lower concourse of a sideline seating stands. Location shown is where the decking is supported by the end bay radial truss (at bottom of photo) of the sideline seating stand.*

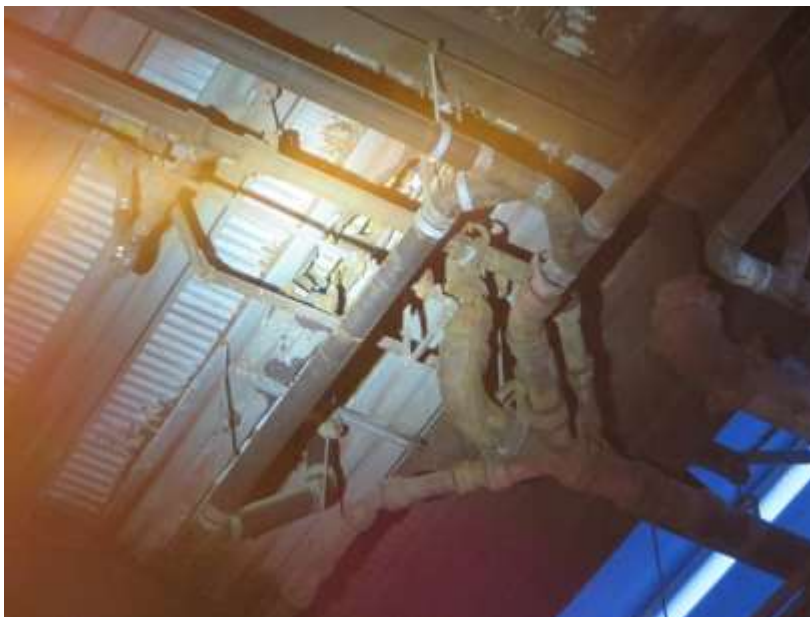
*Figure 23. Deteriorated decking and sub-decking at plumbing penetrations servicing a toilet facility in a sideline seating stand.*

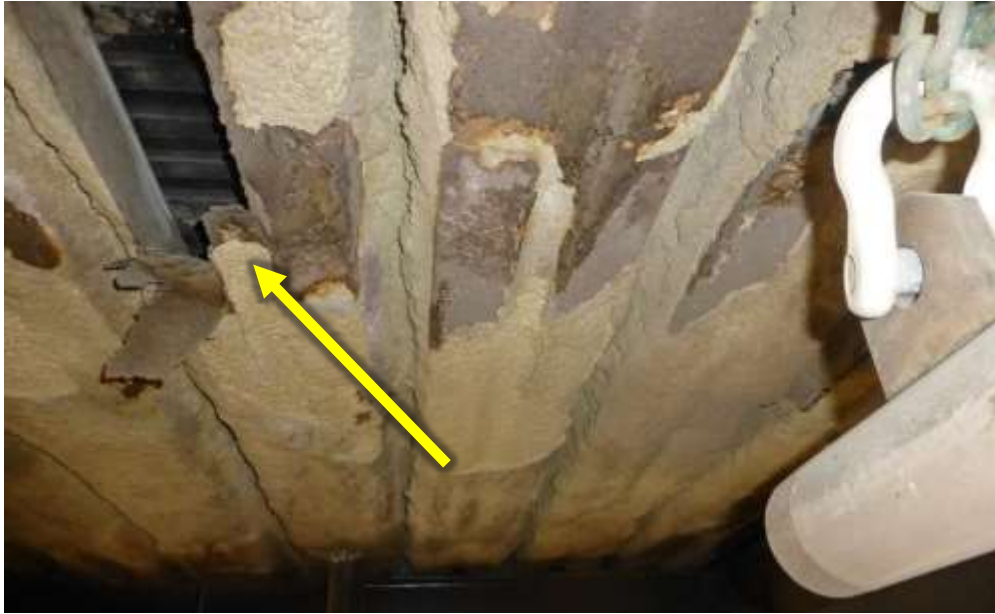
*Figure 24. Corrosion has occurred through the lightweight sub-decking hat channel that supports an electrical room floor at the Northeast Sideline seating stand.*

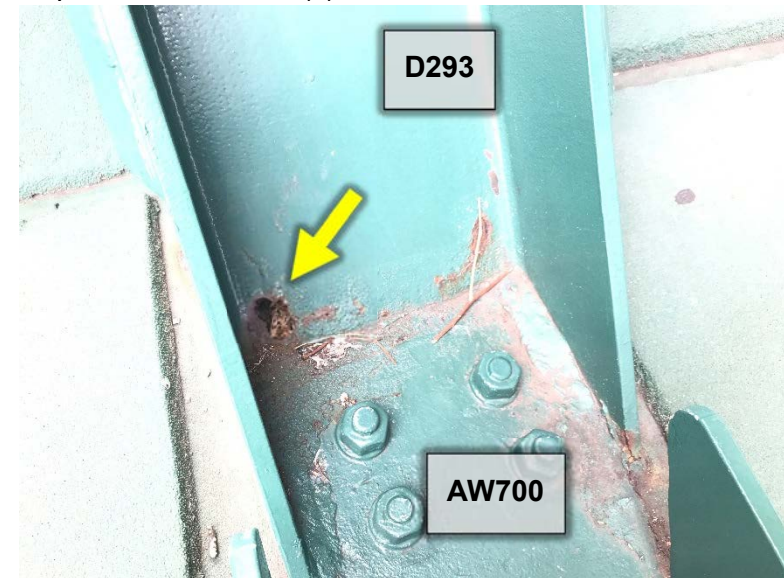
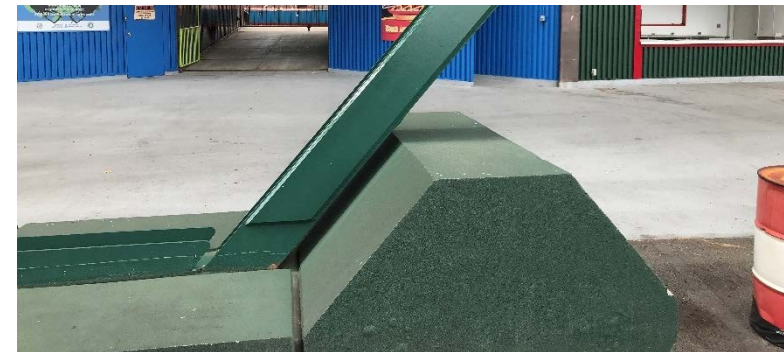
**Group 02 - Endzone Exterior Diagonal Braces on Line F.9:**  
**Corrosion at Connections to Concrete Substructure at Concrete Barrier**

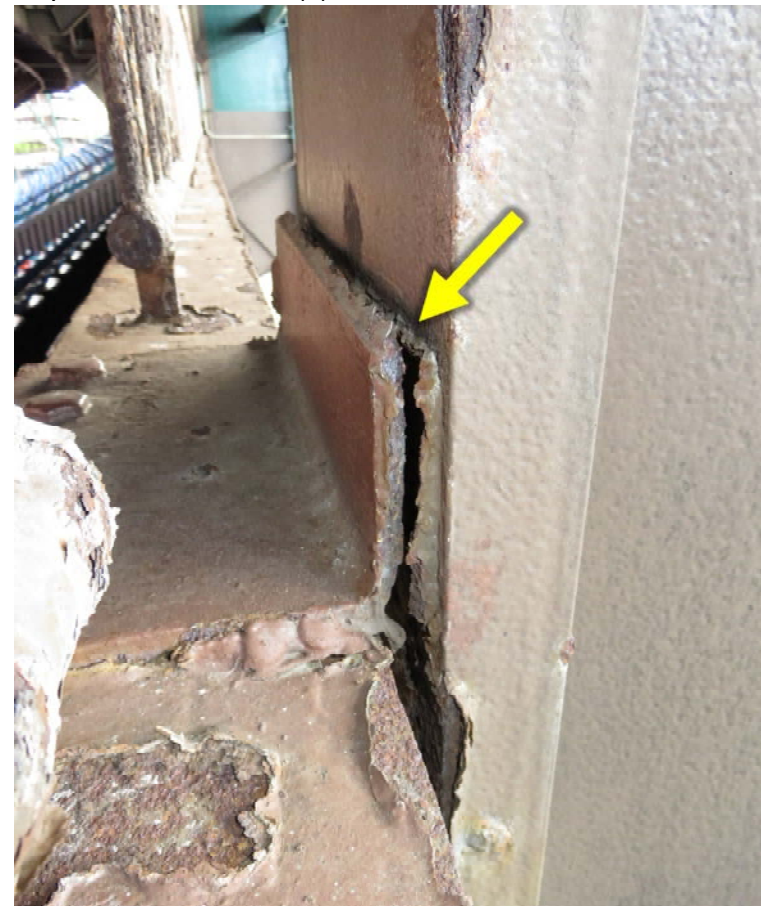
**Group 03 - Plate Girders on Line F at Top of Blue Seating**  
**Section: Corrosion and Cracked Welds at Connections to Raker**  
**Frames**

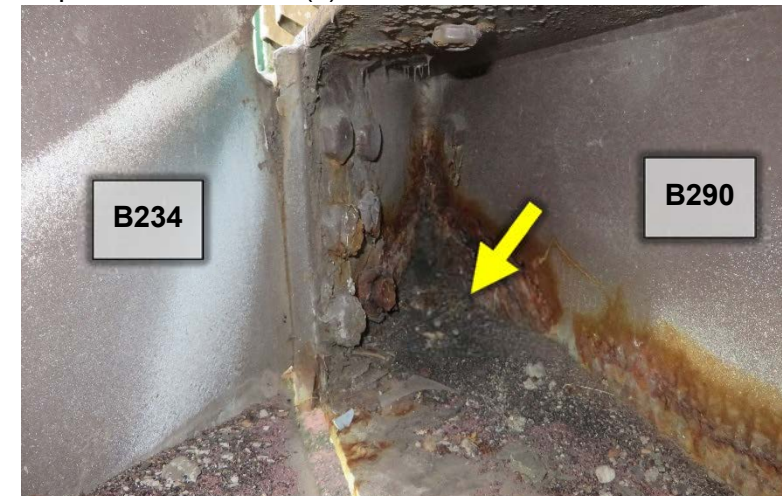
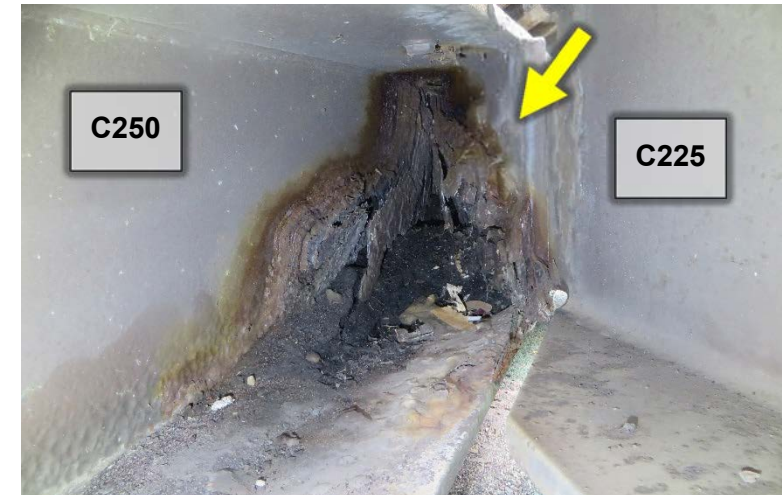
**Group 04 - Lower Chord Horizontal Truss at Field Level:**  
**Corrosion at Connection of Acutely Skewed Horizontal Truss**  
**Diagonal Brace to Bottom Chord of Radial Truss at End Frames**

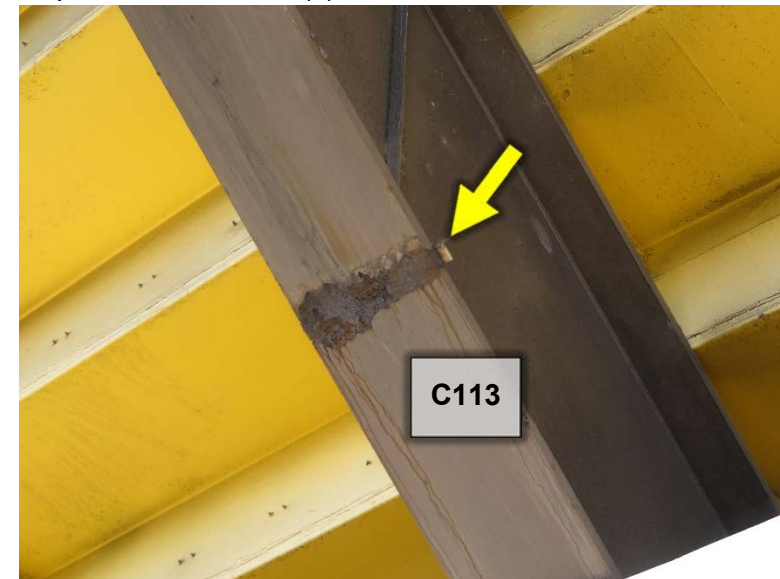
**Group 05 - Fiberglass Angles: Overhead Falling Hazard and Corrosion at Attachment to Raker Frame Members Above Concourses**

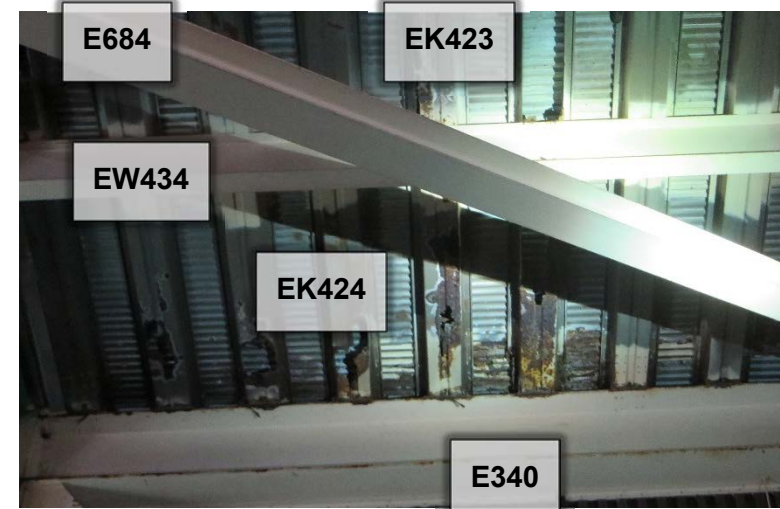
**Group 06 - Lightweight, Thin-System Floor Decking: Corrosion of Metal Deck**

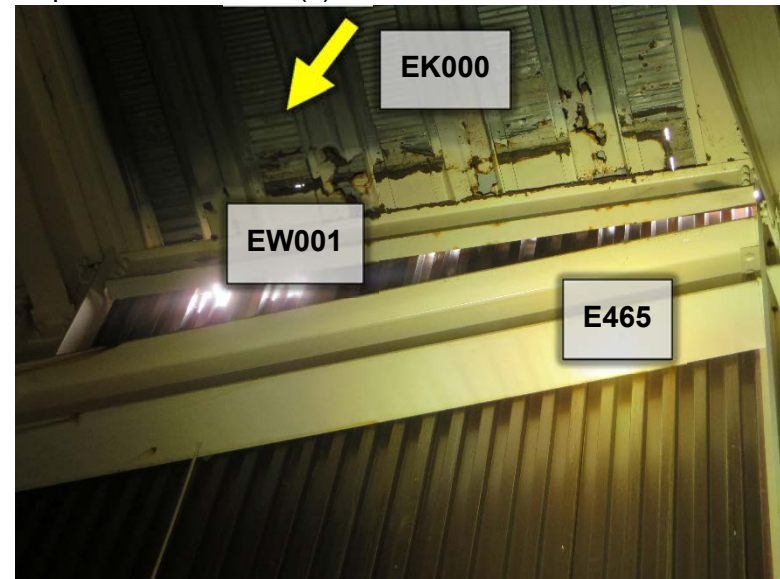
**Group 07 - Orange Cross Aisle End Frame Beams: Corrosion at Beam Top Flange Supporting Deck Edges**

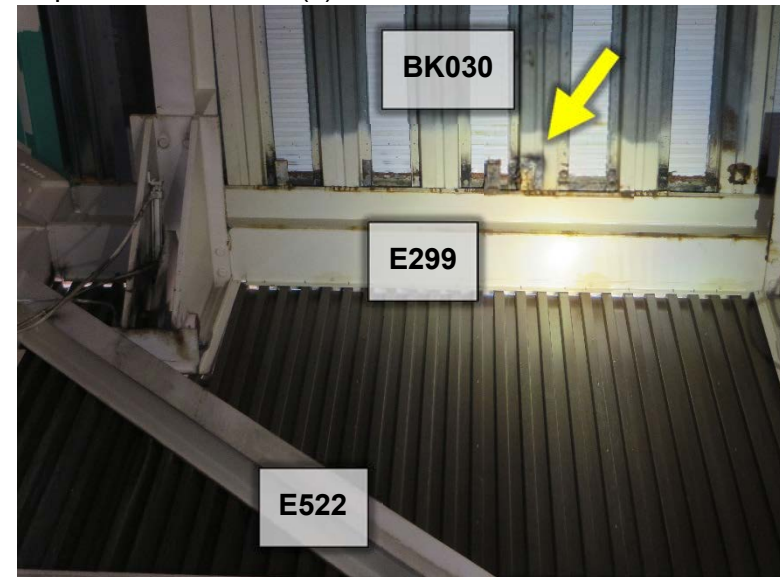
**Group 08 - Lower Concourse End Frame Beams: Corrosion at Beam Top Flange Supporting Deck Edges**

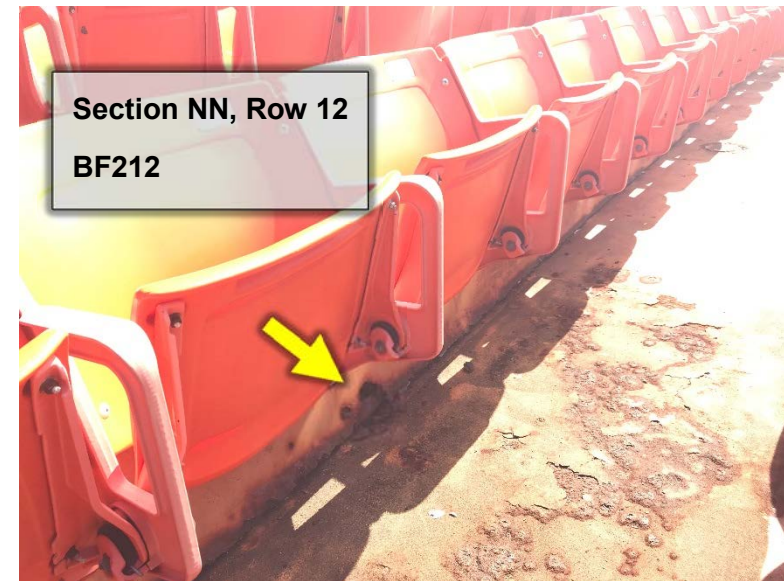
**Group 09 - Seat Plate Tread-and-Riser Rows: Corrosion at Seat Plates**

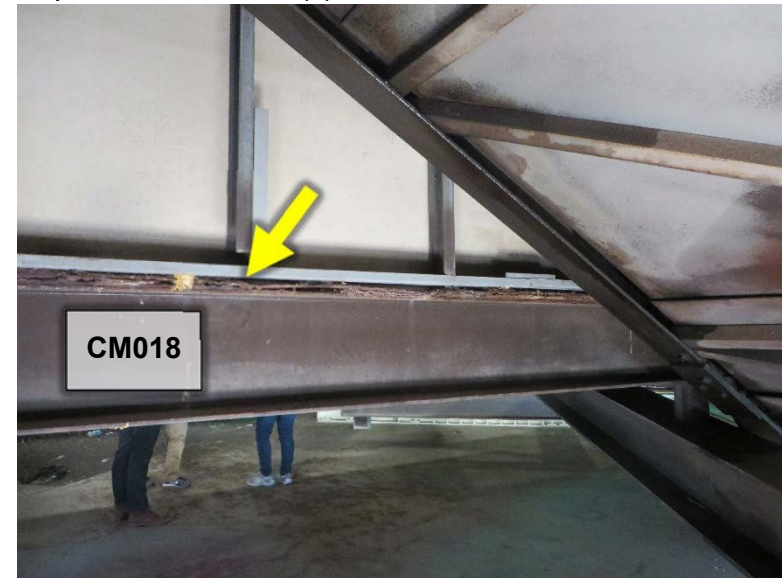
**Group 10 - Escalator Framing: Corrosion of Girders at Lower Concourse and of Beams at Field Level Landing**

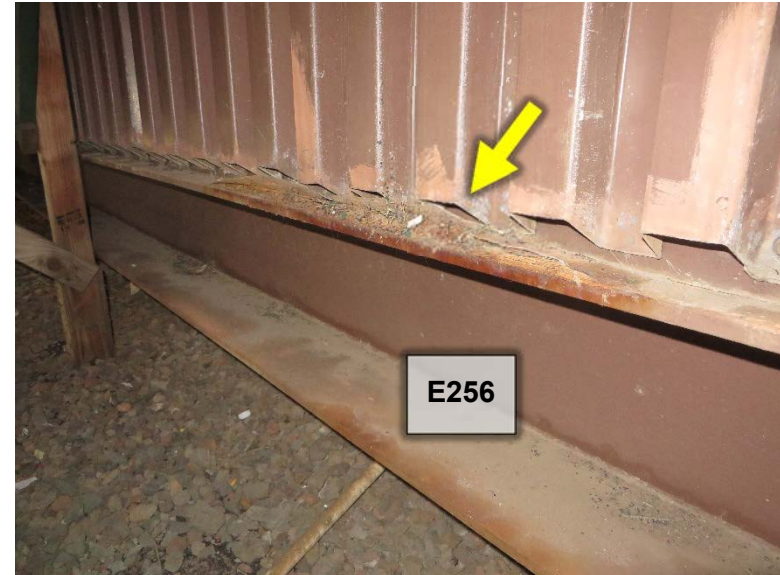
**Group 11 - Radial Truss Framing Members: Corrosion at End Frame Radial Trusses**

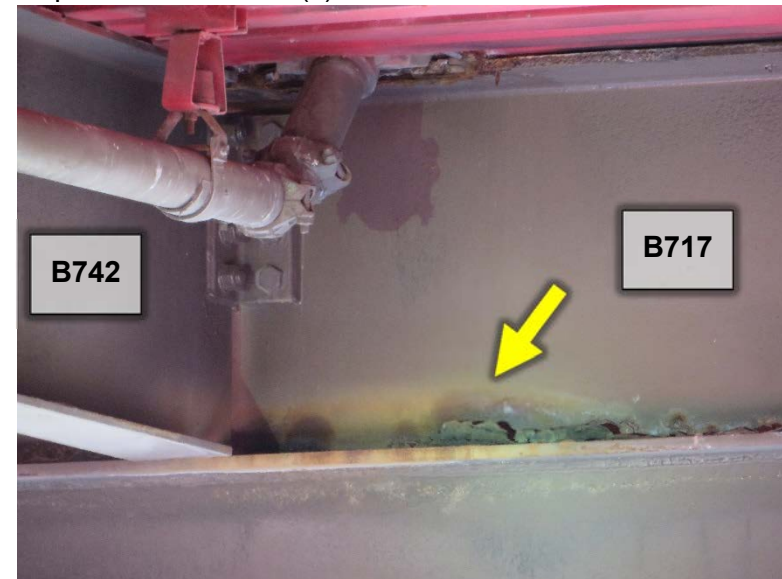
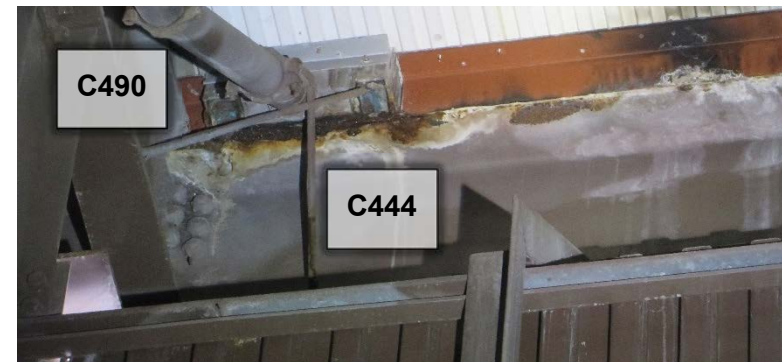
**Group 12 - Upper and Lower Concourse Levels, Outer Perimeter**  
**Edge Beams: Corrosion at Beams**

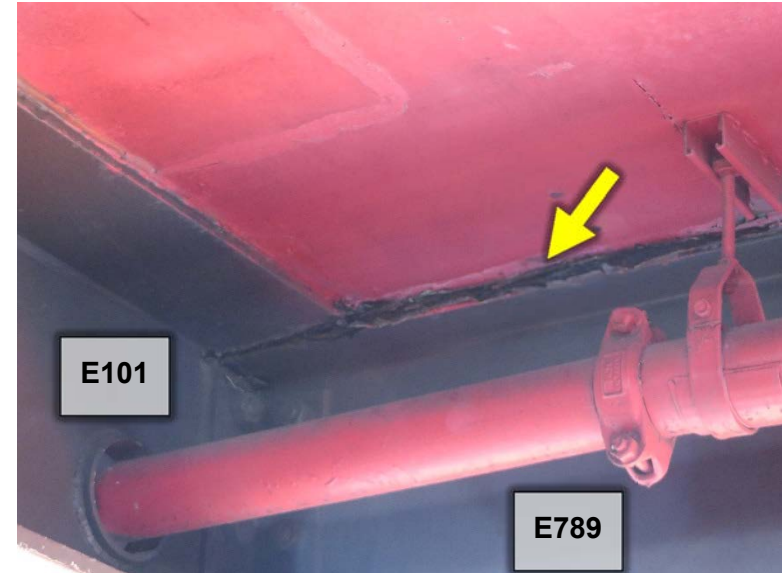
**Group 13 - Red Seats Field-Fronting Beam: Flange Corrosion at Seat Plate Edges**

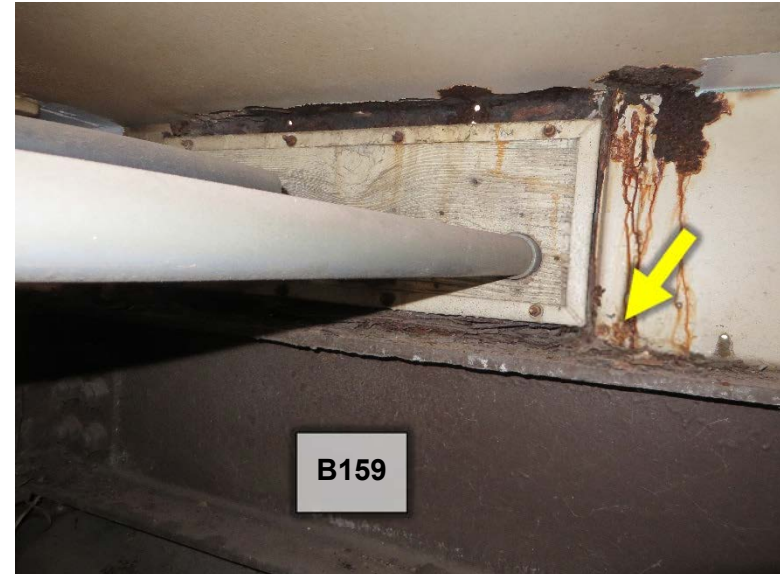
**Group 14 - Field-Fronting Framing Members along Grid Line A:  
Corrosion at Seat Plate Opening for Utilities**

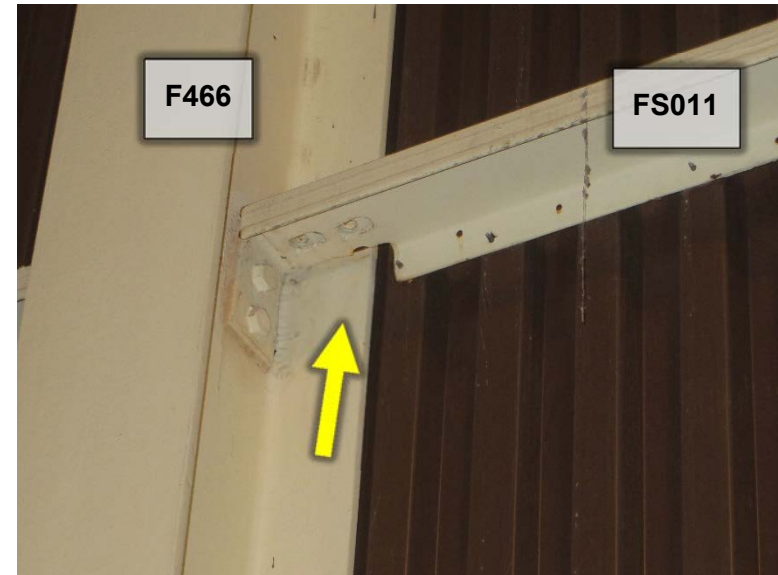
**Group 15 - Sideline Stands Siding Girt Connections at End Frame**

**Walls: Missing Bolts at Connections**

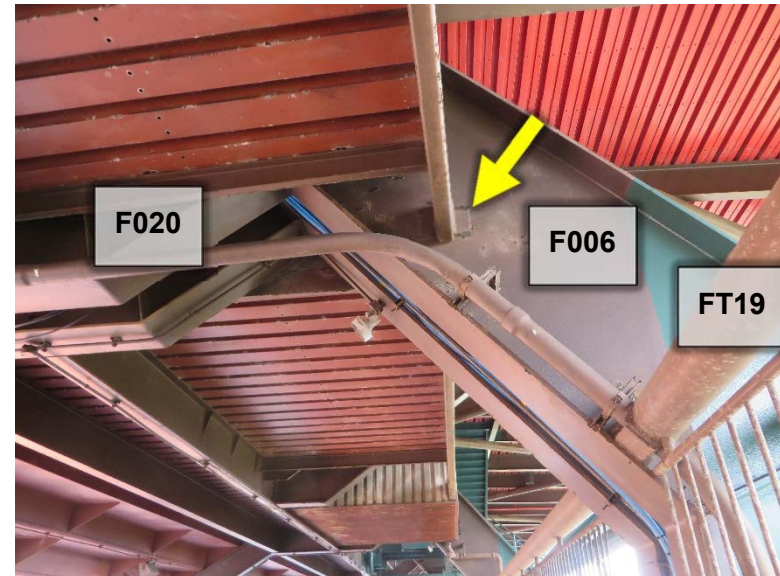
**Group 16 - Press Box Floor Framing Member Connection:  
Corrosion at Connection**

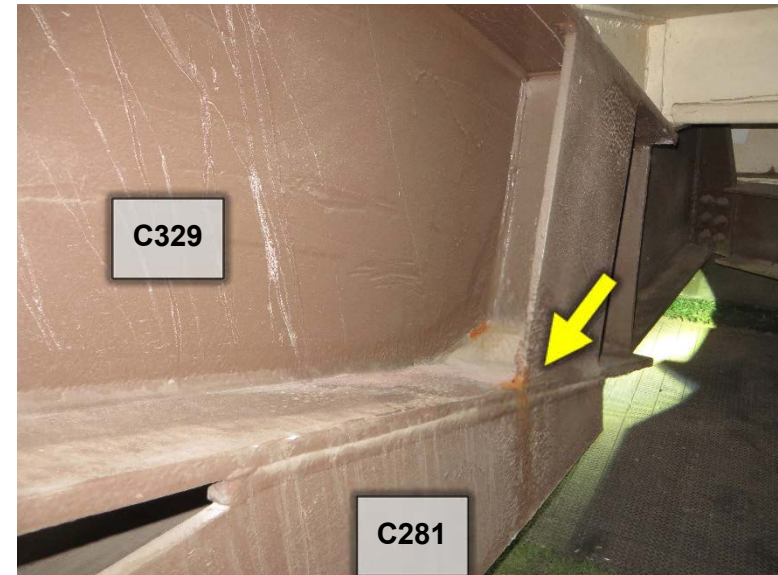
**Group 17 - Radial Trusses Supporting Orange Seats: Isolated corrosion at connections**

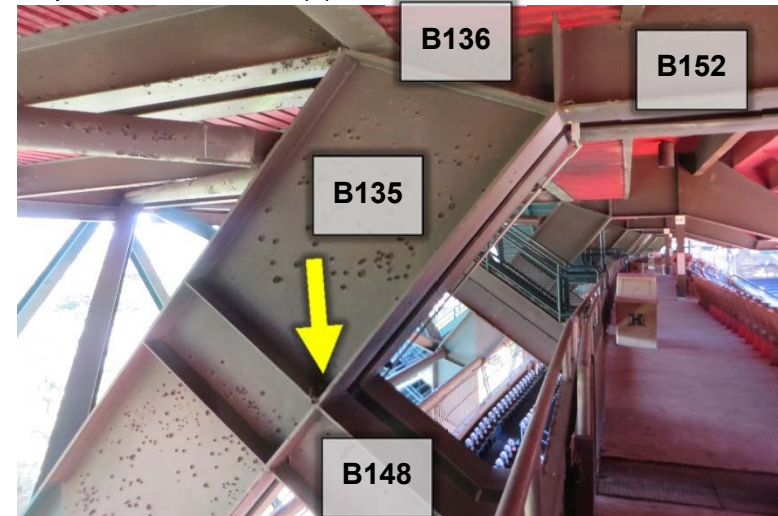
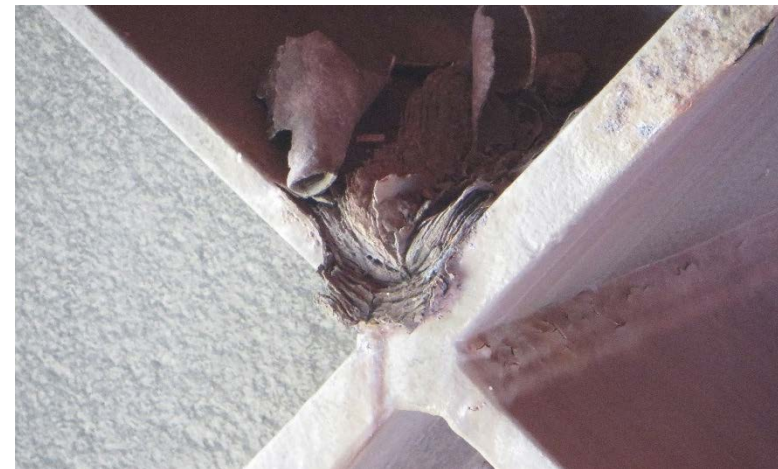
**Group 18 - Raker Frame at Box Seats Level: Corrosion at Raker  
Plate Welded Connections**
