ALOHA STADIUM
Structural and Safety Evaluations:
Weathering Steel and Decking Corrosion Assessment
DAGS Job No. 12-10-0651
99-500 Salt Lake Boulevard
Halawa, Honolulu County, Hawaii

Final Report
December 12, 2018
WJE No. 2014.6720.1

Table 1. Summary of Recommended Repairs - 2018 Assessment

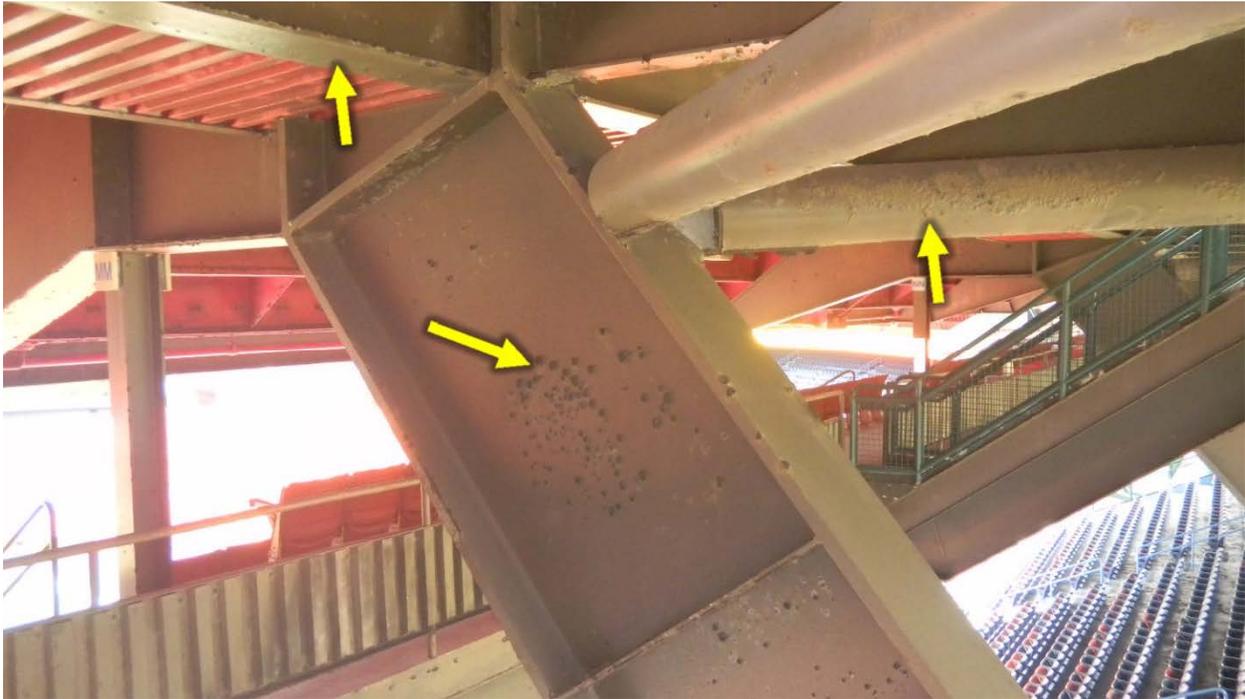
Figure 9. Example of structural steel member classified as Condition State 2

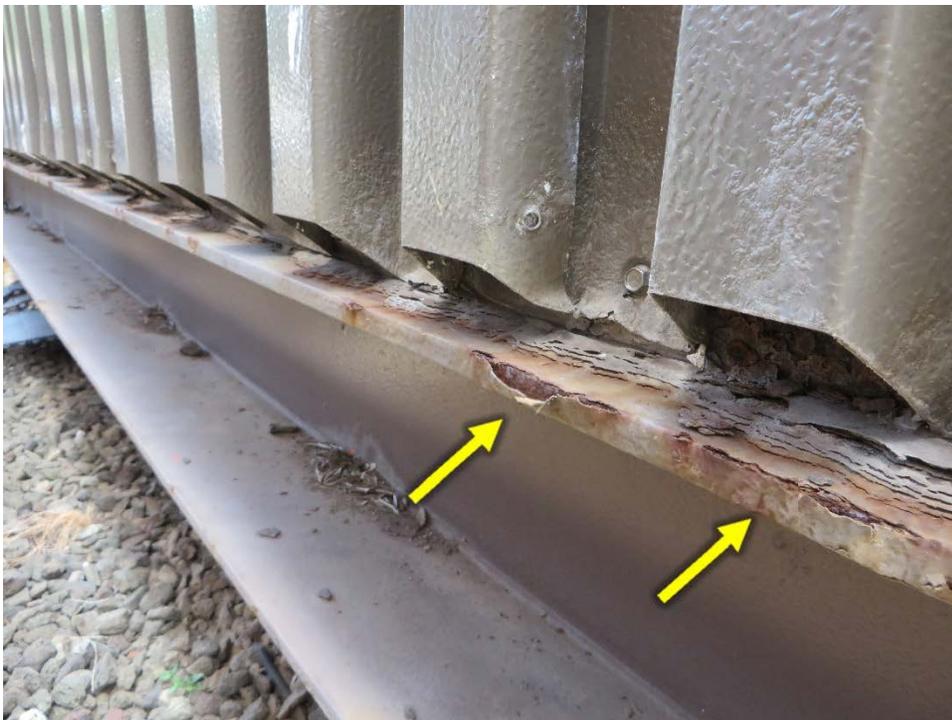
Figure 10. Example of structural steel member classified as Condition State 3.

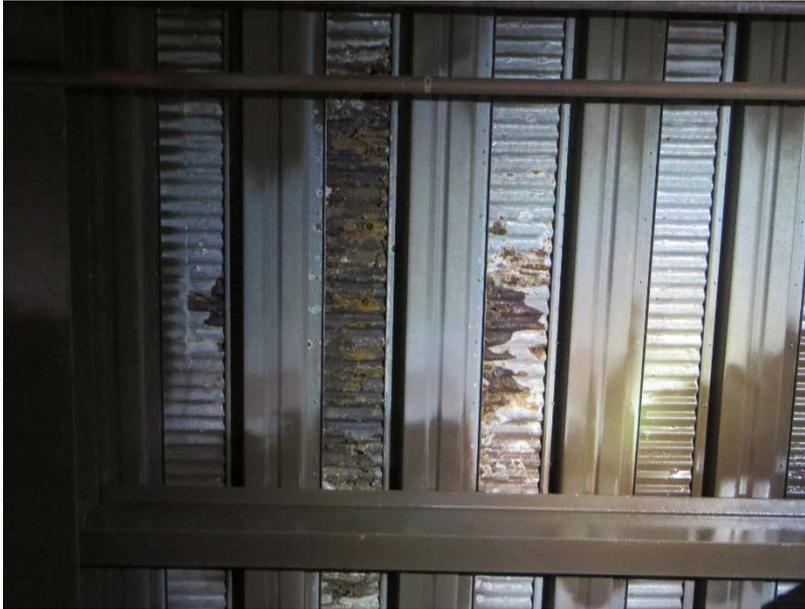
Figure 11. Example of lightweight floor slab decking classified as Condition State 3.

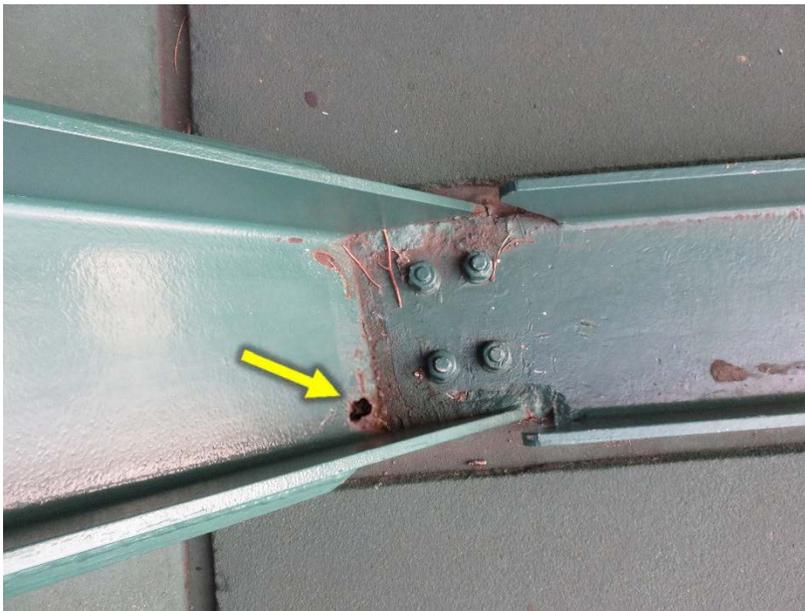
Figure 12. Example of structural steel member classified as Condition State 4. The yellow arrow points to a hole completely corroded through the thickness of the web of the steel member.

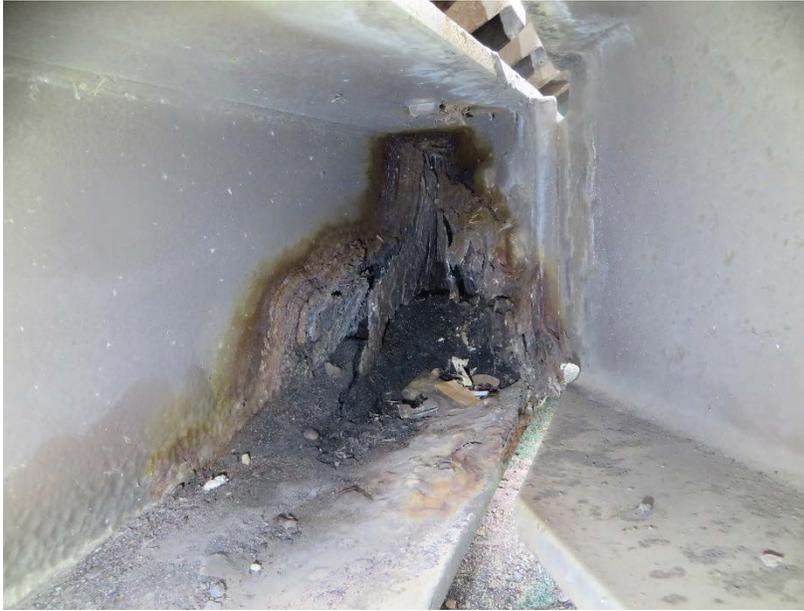
Figure 13. Additional example of structural steel member classified as Condition State 4.

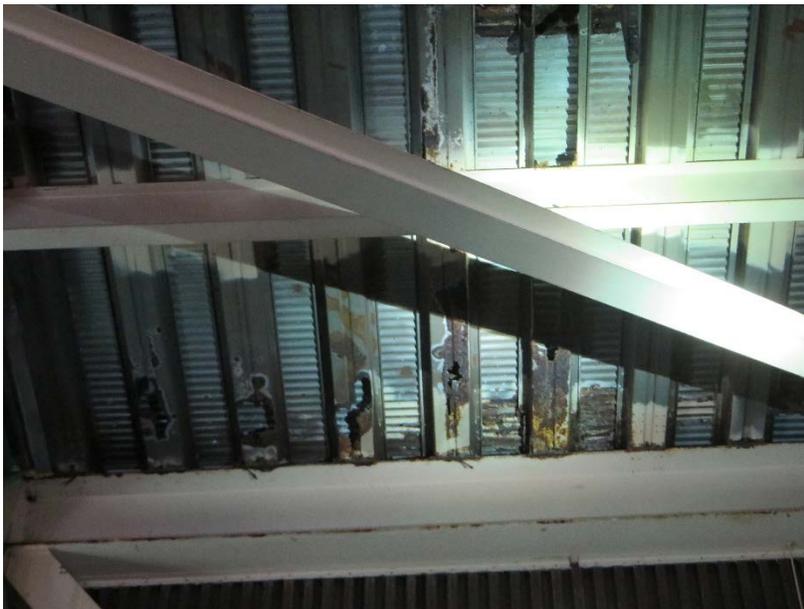
Figure 14. Example of lightweight floor slab decking classified as Condition State 4.

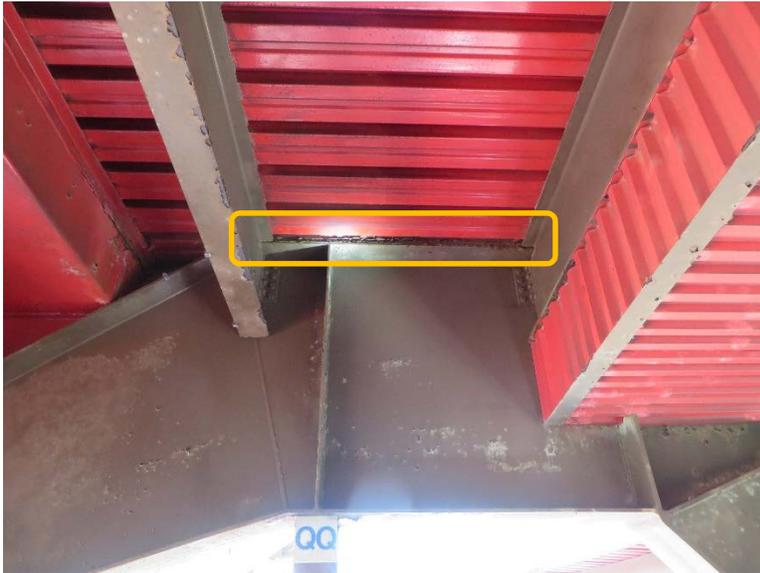
It appears that, over the years, rainwater has entered into operable access hatches in the floor deck at the ends of the cross aisles servicing the Red and Brown seating areas. The access hatches are located immediately above the subject raker beams in the end raker frames. The rainwater appears to have leaked directly onto the top flanges of the raker beams, resulting in notable corrosion to the top flanges of the raker beams due to relatively persistent wetness.

Figure 16. Corroding top flange of deep raker beam supporting the Red seating area. This location is in an end frame of the northeast sideline stands. The deep beam is one component of the cantilever raker assembly that supports the Red and Brown seating areas.

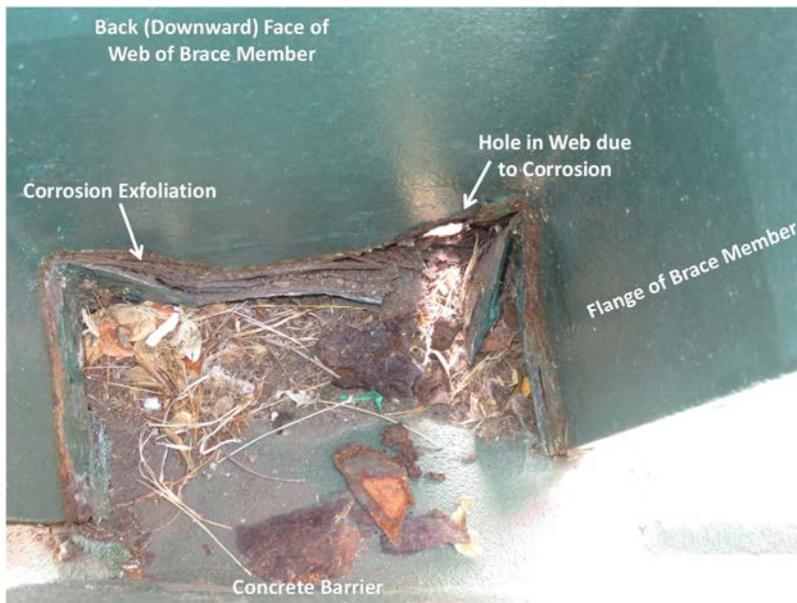
Based on our field measurements and subsequent structural analyses, we find that the current structural capacities of the as-corroded brace members are such that demand-to-capacity ratios are only slightly below 1.0. This means that the remaining structural capacity of the as-corroded brace member only marginally satisfies the structural strength requirements of the current building code.

Figure 18. Annotated photo showing severe corrosion conditions at base connection of steel brace member to the concrete barrier (South endzone).

In any event, the affected braces in the endzone seating stands will almost certainly continue to corrode, and if repairs are not implemented to mitigate the effects of corrosion and to restore structural capacities, the remaining structural capacities of the corroding endzone brace members will almost certainly be reduced to less than the structural capacities required by the building code. As summarized later in this report, it is recommended that the affected endzone braces be structurally repaired commencing immediately.

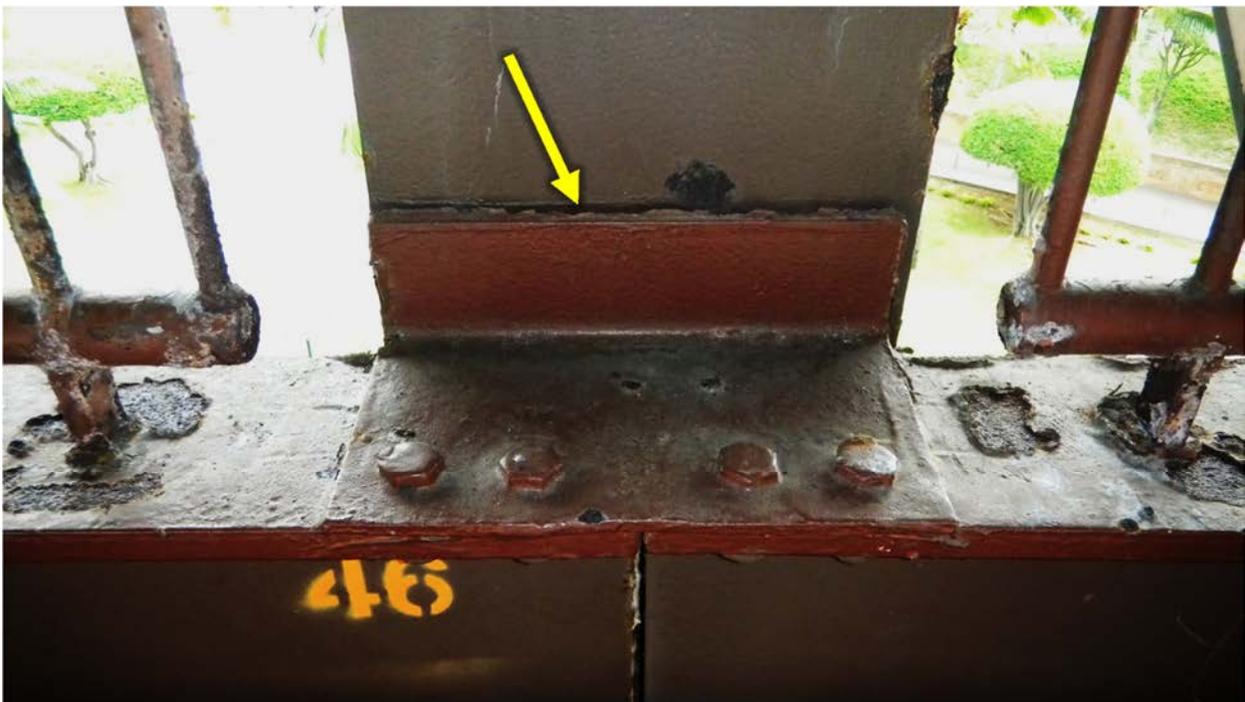
Water becomes entrapped between the vertical leg of the angle and flange of the raker column. The entrapped moisture is causing corrosion on the connection angle and the flange of the raker column. The expansion of the corrosion products between the connection angle and the flange of the raker column applies a prying force to the connecting pieces that has resulted in partial or complete failure of the weld between the connection angle and the raker column flange at many of these connections (Figure 20 and Figure 21). Continued corrosion at these connections will result in further cracking of the affected welds. At the time of our survey, the welds have failed to various degrees at approximately 75 percent of these angle connections.

Figure 20. The indicated weld line between connection angle and raker column flange has completely fractured.

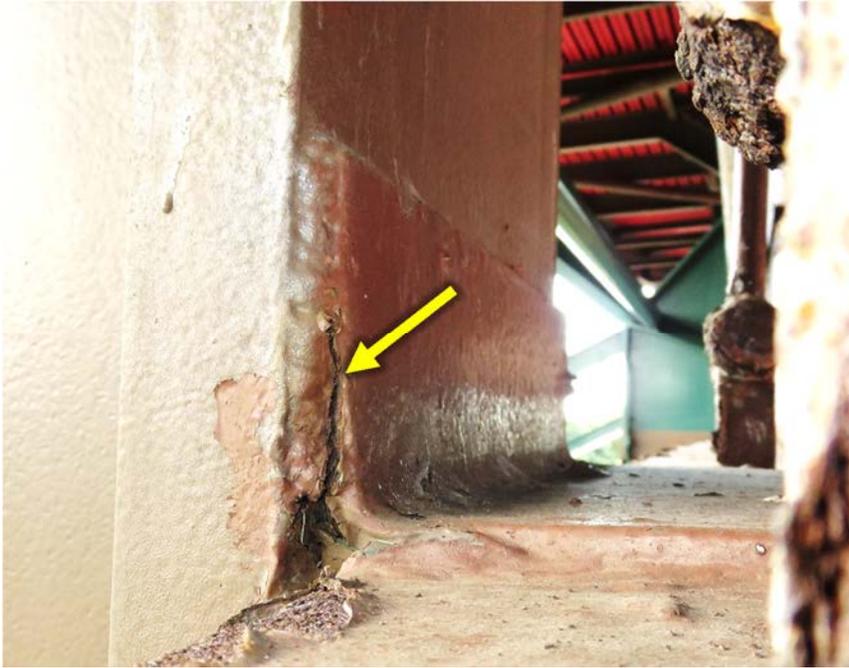
Figure 21. The weld between the connection angle and raker column flange at this location has partially fractured.

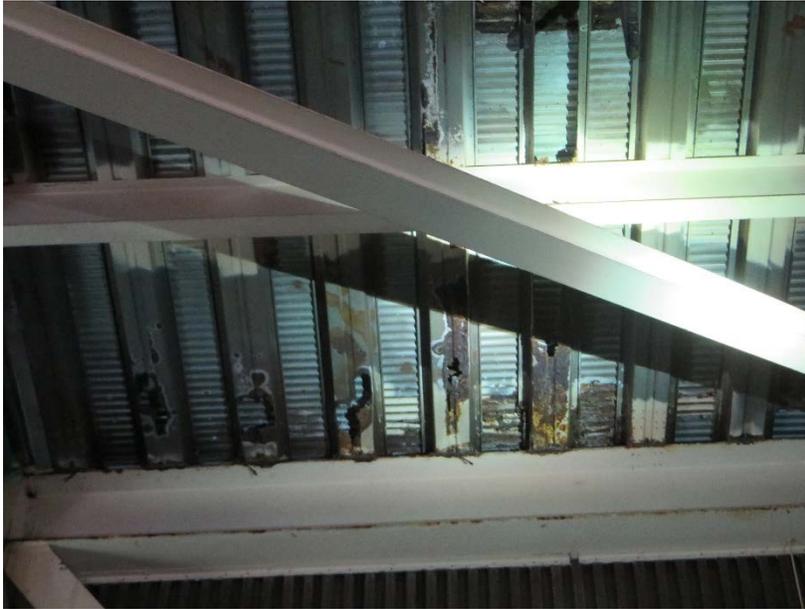
Figure 22. Representative severe (CS4) corrosion conditions observed in decking and hat-channel sub-decking of the lightweight floor system of the lower concourse of a sideline seating stands. Location shown is where the decking is supported by the end bay radial truss (at bottom of photo) of the sideline seating stand.

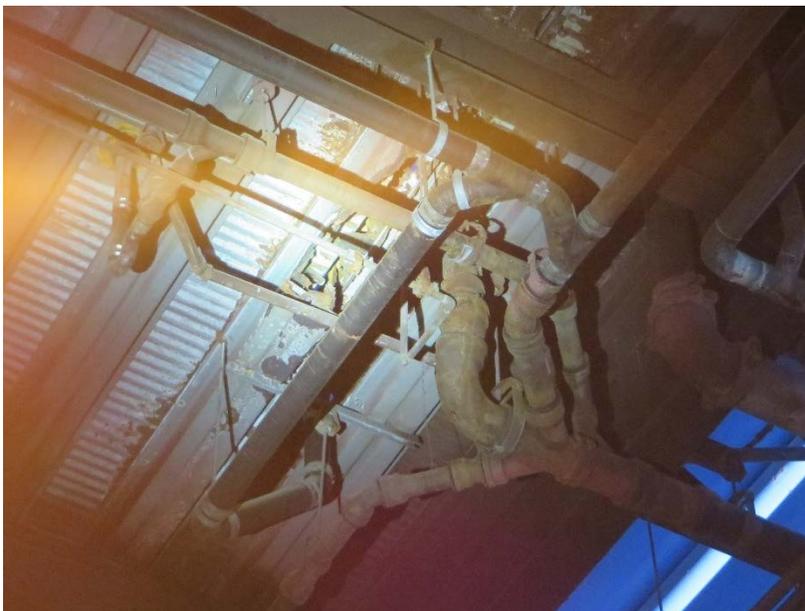
Figure 23. Deteriorated decking and sub-decking at plumbing penetrations servicing a toilet facility in a sideline seating stand.

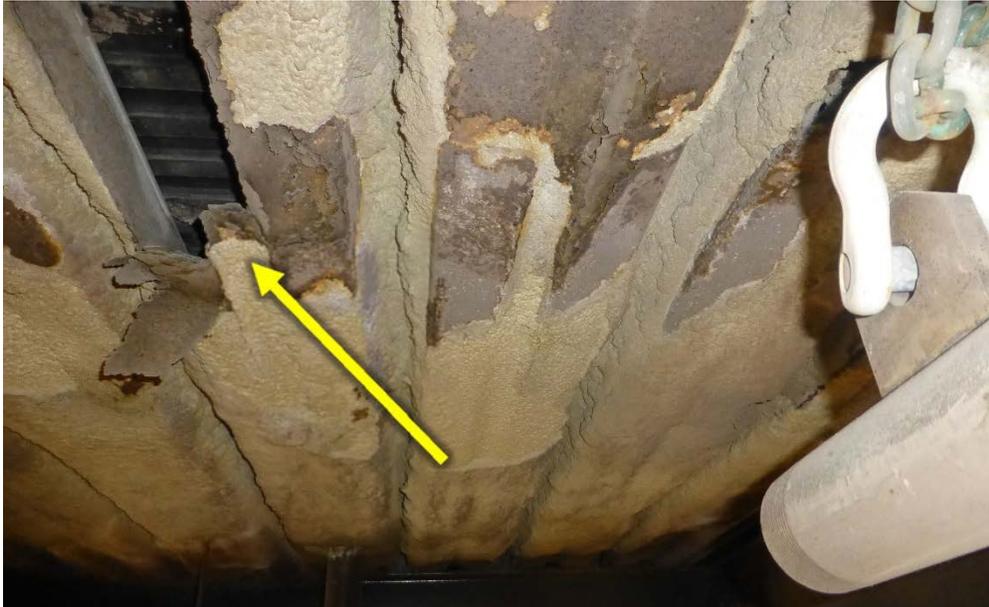
Figure 24. Corrosion has occurred through the lightweight sub-decking hat channel that supports an electrical room floor at the Northeast Sideline seating stand.

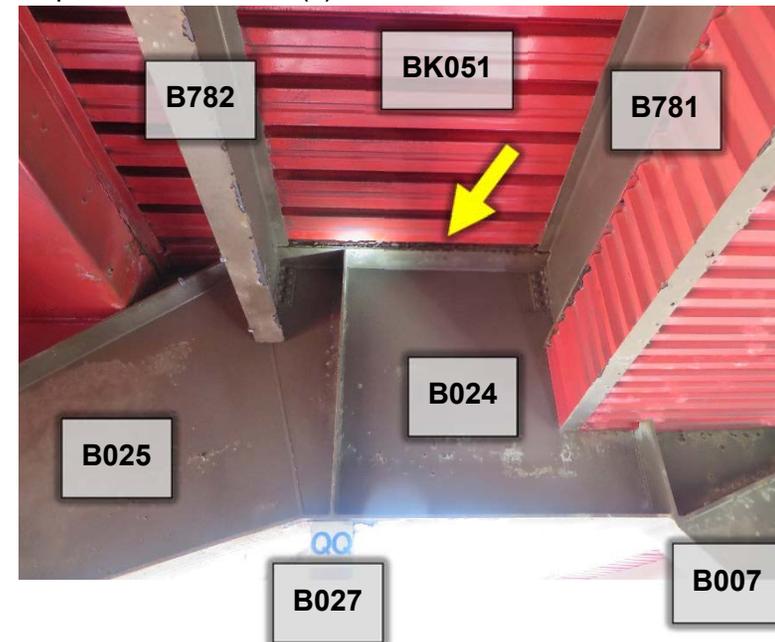
**Group 02 - Endzone Exterior Diagonal Braces on Line F.9:
Corrosion at Connections to Concrete Substructure at Concrete
Barrier**

CS4 Piece Count: 4

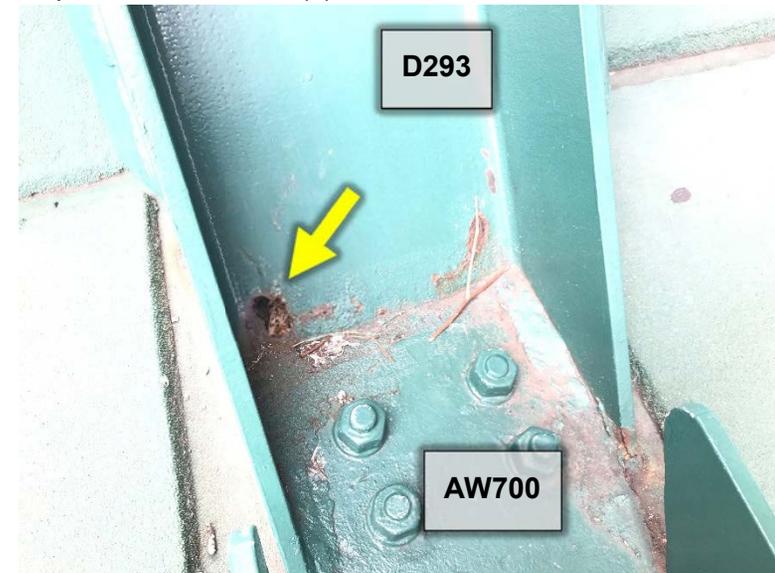
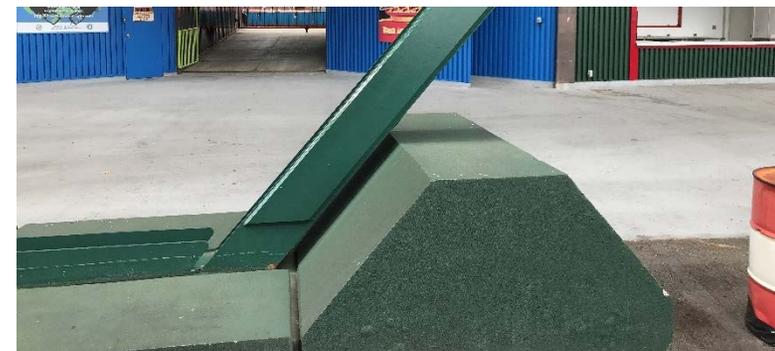
Group 03 - Plate Girders on Line F at Top of Blue Seating
Section: Corrosion and Cracked Welds at Connections to Raker
Frames

CS4 Piece Count: 30

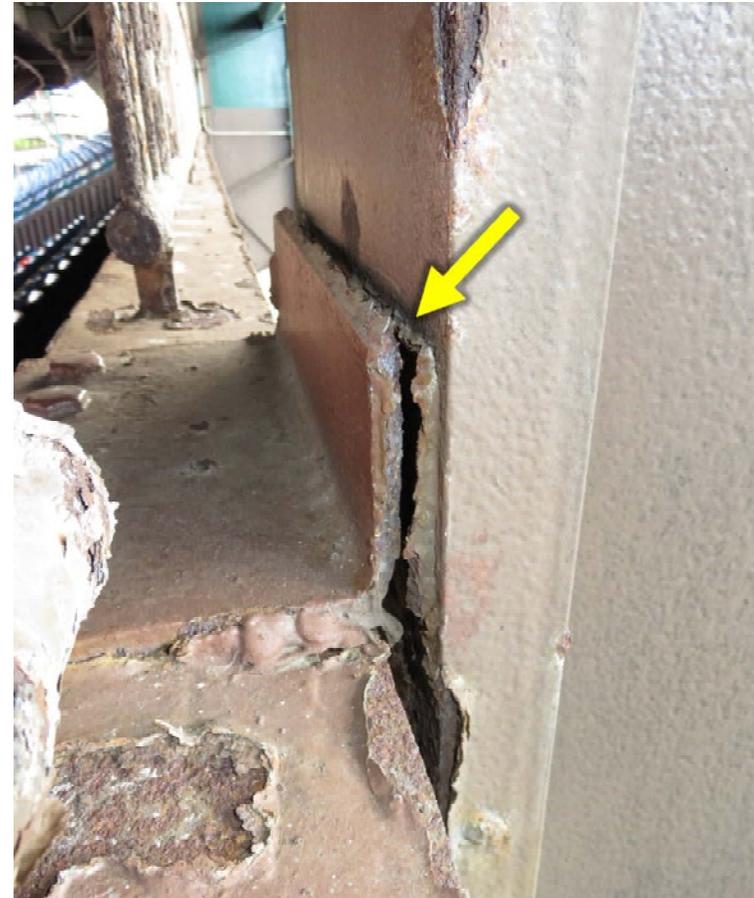
**Group 04 - Lower Chord Horizontal Truss at Field Level:
Corrosion at Connection of Acutely Skewed Horizontal Truss
Diagonal Brace to Bottom Chord of Radial Truss at End Frames**

CS4 Piece Count: 6

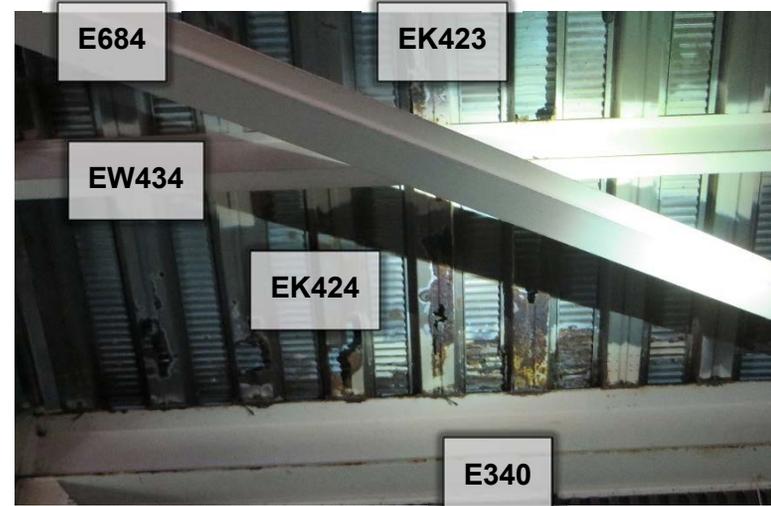
Group 07 - Orange Cross Aisle End Frame Beams: Corrosion at Beam Top Flange Supporting Deck Edges

CS4 Piece Count: 2

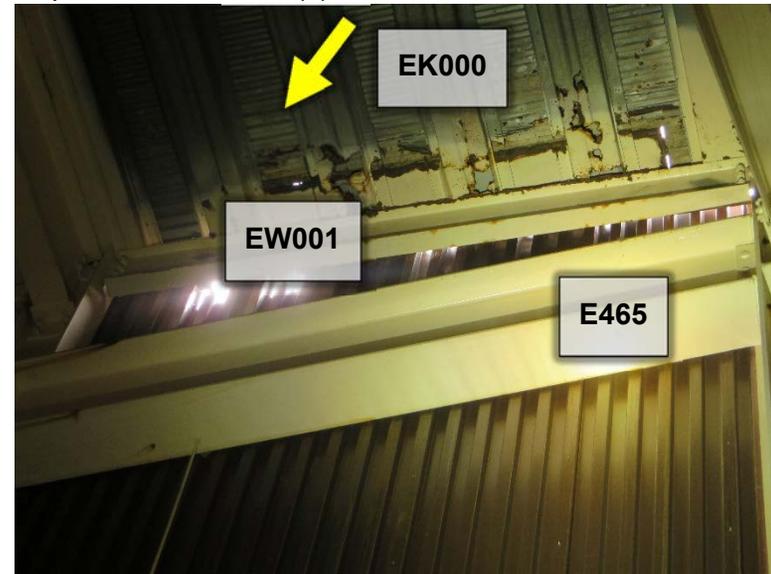
Group 08 - Lower Concourse End Frame Beams: Corrosion at Beam Top Flange Supporting Deck Edges

CS4 Piece Count: 4

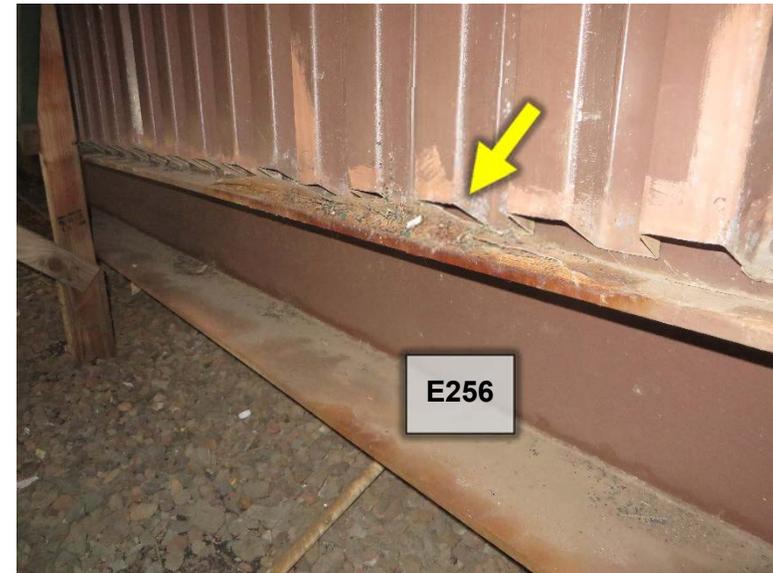
Group 12 - Upper and Lower Concourse Levels, Outer Perimeter
Edge Beams: Corrosion at Beams

CS4 Piece Count: 1

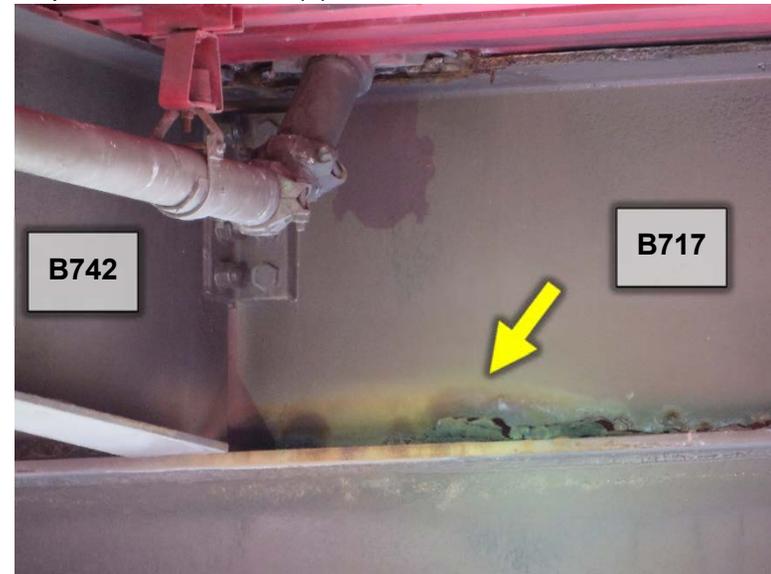
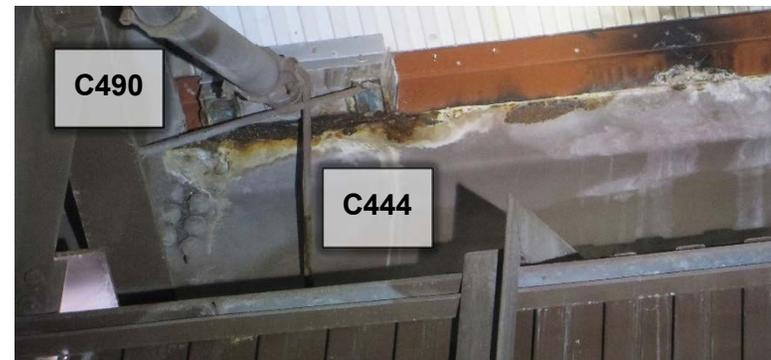
Group 13 - Red Seats Field-Fronting Beam: Flange Corrosion at Seat Plate Edges

CS4 Piece Count: 0

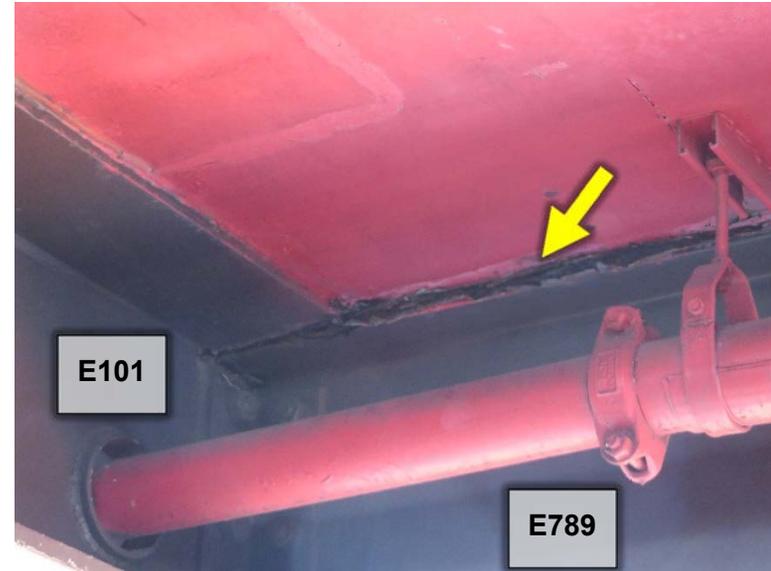
**Group 14 - Field-Fronting Framing Members along Grid Line A:
Corrosion at Seat Plate Opening for Utilities**

CS4 Piece Count: 0

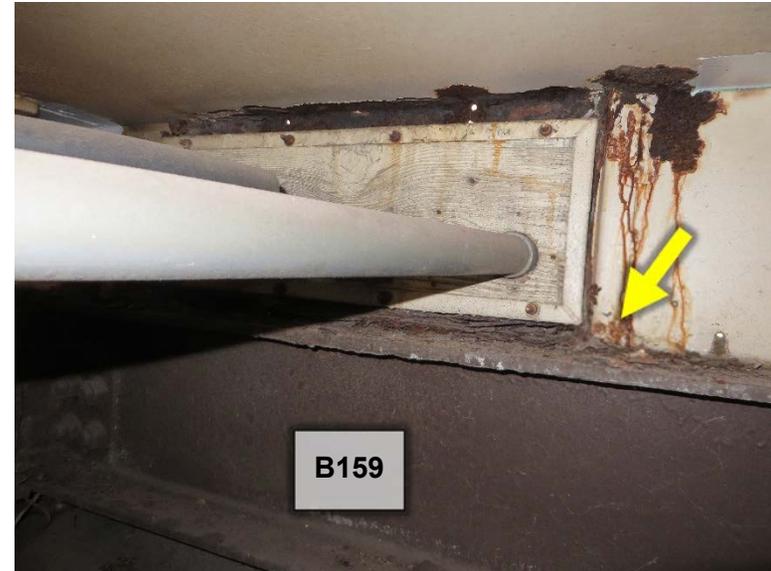
Group 15 - Sideline Stands Siding Girt Connections at End Frame

Walls: Missing Bolts at Connections

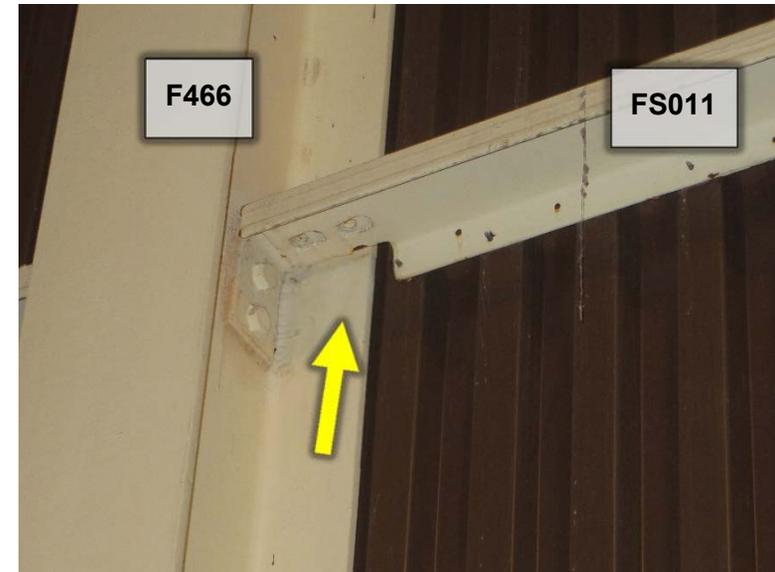
**Group 16 - Press Box Floor Framing Member Connection:
Corrosion at Connection**

CS4 Piece Count: 0

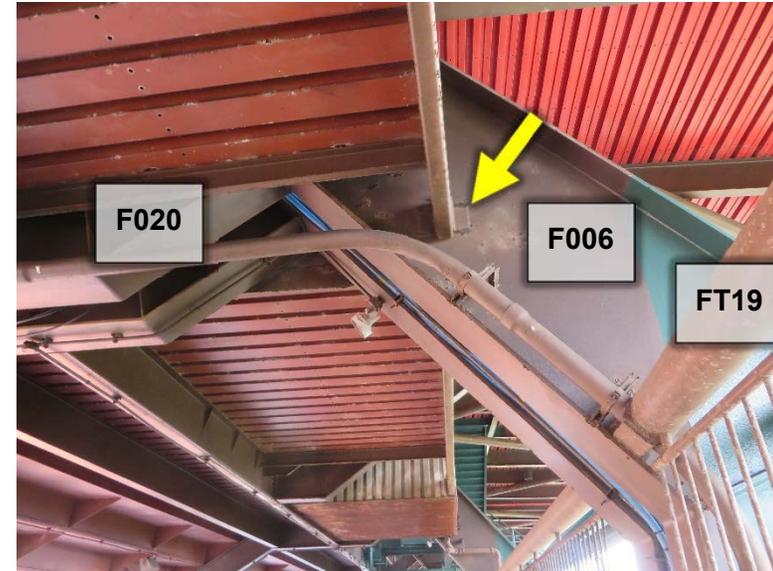
Group 17 - Radial Trusses Supporting Orange Seats: Isolated corrosion at connections

CS4 Piece Count: 0

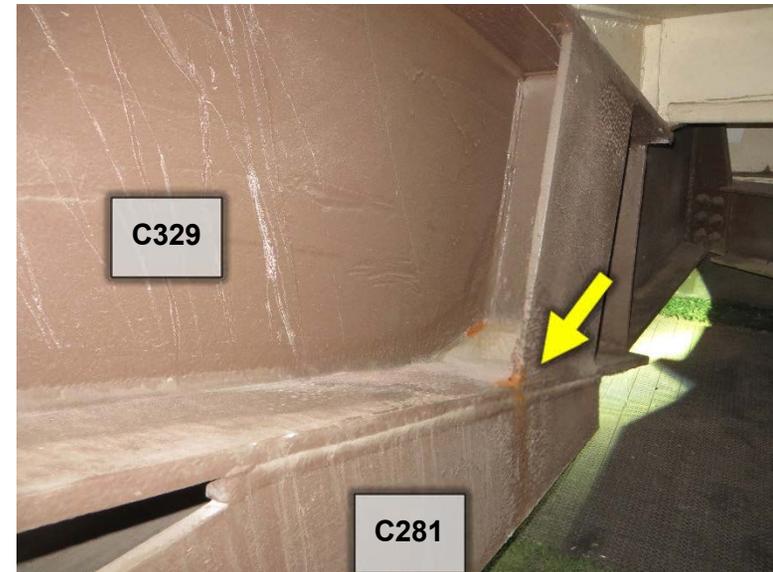
Group 18 - Raker Frame at Box Seats Level: Corrosion at Raker Plate Welded Connections

CS4 Piece Count: 0
