**ALOHA STADIUM**  
**Structural and Safety Evaluations:**  
**Weathering Steel and Decking Corrosion Assessment**  
DAGS Job No. 12-10-0651  
99-500 Salt Lake Boulevard  
Halawa, Honolulu County, Hawaii

**Final Report**  
December 12, 2018  
WJE No. 2014.6720.1

### **Weathering Steel and Decking Corrosion Assessment**

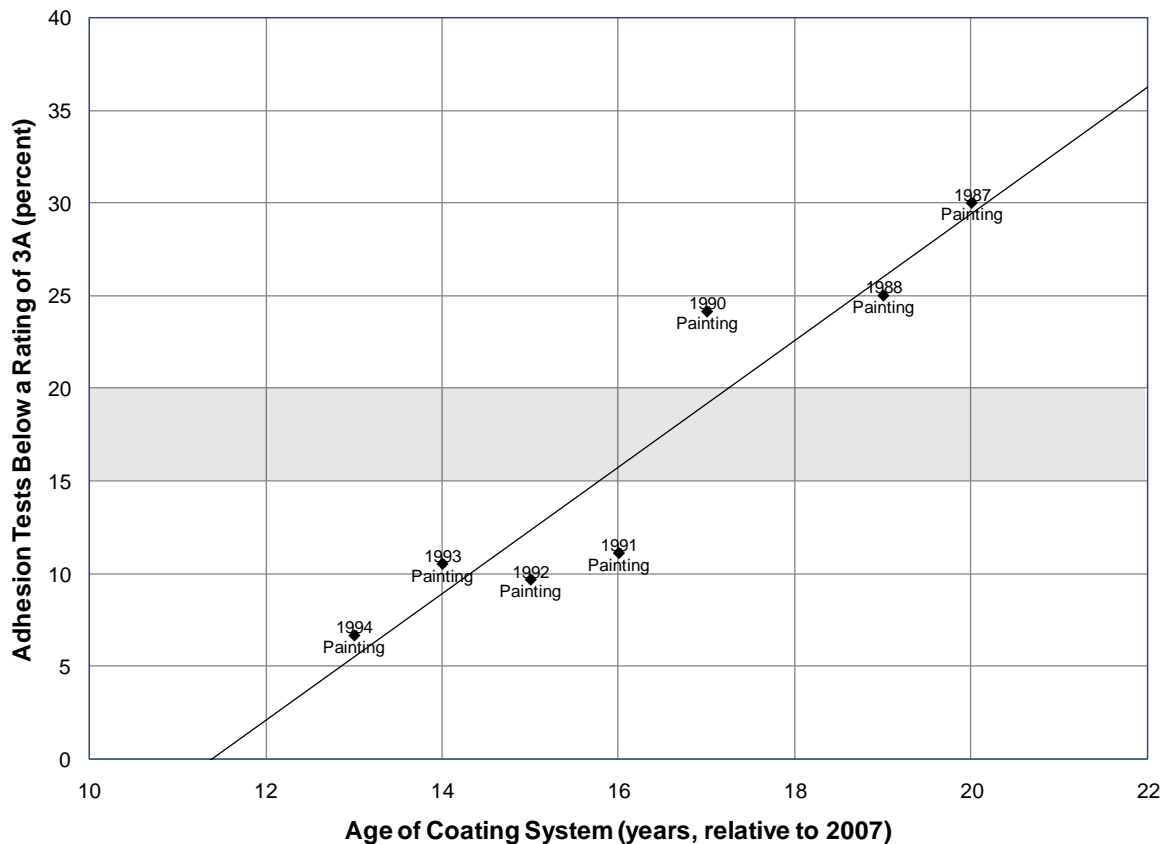
An Overcoating Acceptance Criteria was developed on the basis of commonly-accepted industry practices for acceptable levels of adhesion, thickness, and degree of corrosion in combination with our own experience with coating systems and exercise of our professional judgment. When the Overcoating Acceptance Criteria was applied to the field test results, it was found that the coatings of a significant portion of the coated components at Aloha Stadium were not suitable for overcoating. At the time of the study in 2007-2008, all of the existing protective coatings at Aloha Stadium had aged more than 10 years, and some had been in service for 20 or more years. The field testing revealed that deterioration of the coatings, as measured by adhesion testing, was increasing with age (Figure 5). For the generic type of existing coating system, original degree of surface preparation, and the given environment, industry references for service life indicated 10 years to be the ideal age at which to apply a maintenance overcoat to the generic type of existing coating system utilized at the stadium, and that practical service life was fully exhausted at 16 years.

*Figure 5. Age of the coating system (relative to 2007) versus the proportion of low adhesion results determined for certain members tested in 2007. The linear trend line of the plotted data is shown. The shaded band in the range of 15 to 20 percent of adhesion tests having poor ratings represents the starting point where any economic benefit that may be realized by overcoating may be offset by costs of surface preparation. Since the time that this data plot was prepared in 2007, the coatings applied during 1991 to 1994 have reached ages of at least 24 years (as of 2018) and older, suggesting that adhesion test results on these coatings would likely fall above the shaded band if these coatings were retested at this current age.*

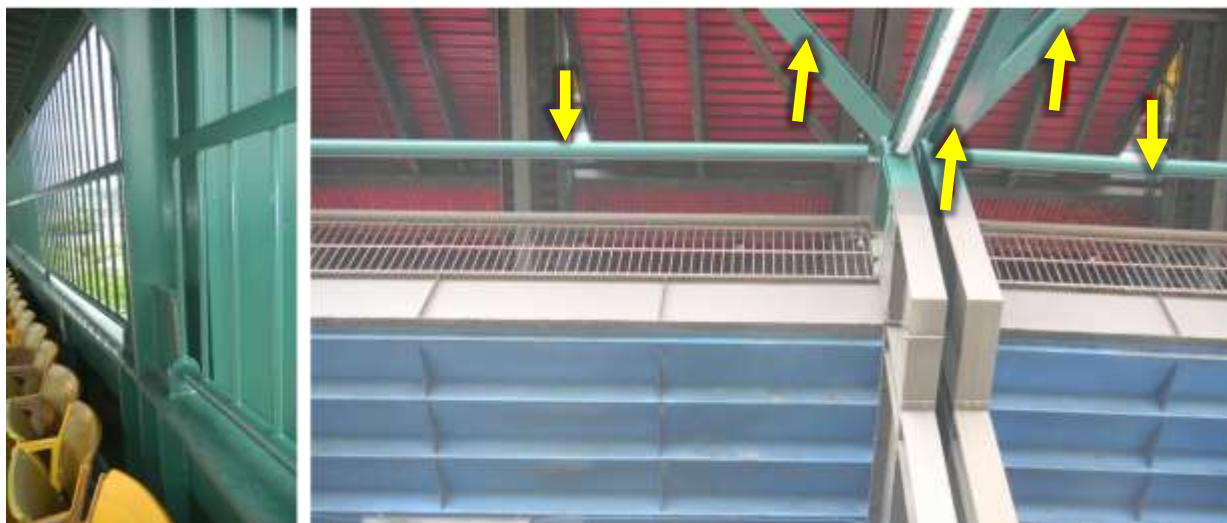
- Condition State 1 (CS1) – No discernable coating failure on steel members (Figure 8) or the visible surfaces of the sub-decking hat channels or the decking itself; therefore, no corrosion is assumed. These members and decking panels pose no known immediate concern for health and safety of occupants of the structure.

*Figure 8. Examples of structural steel members classified as Condition State 1*

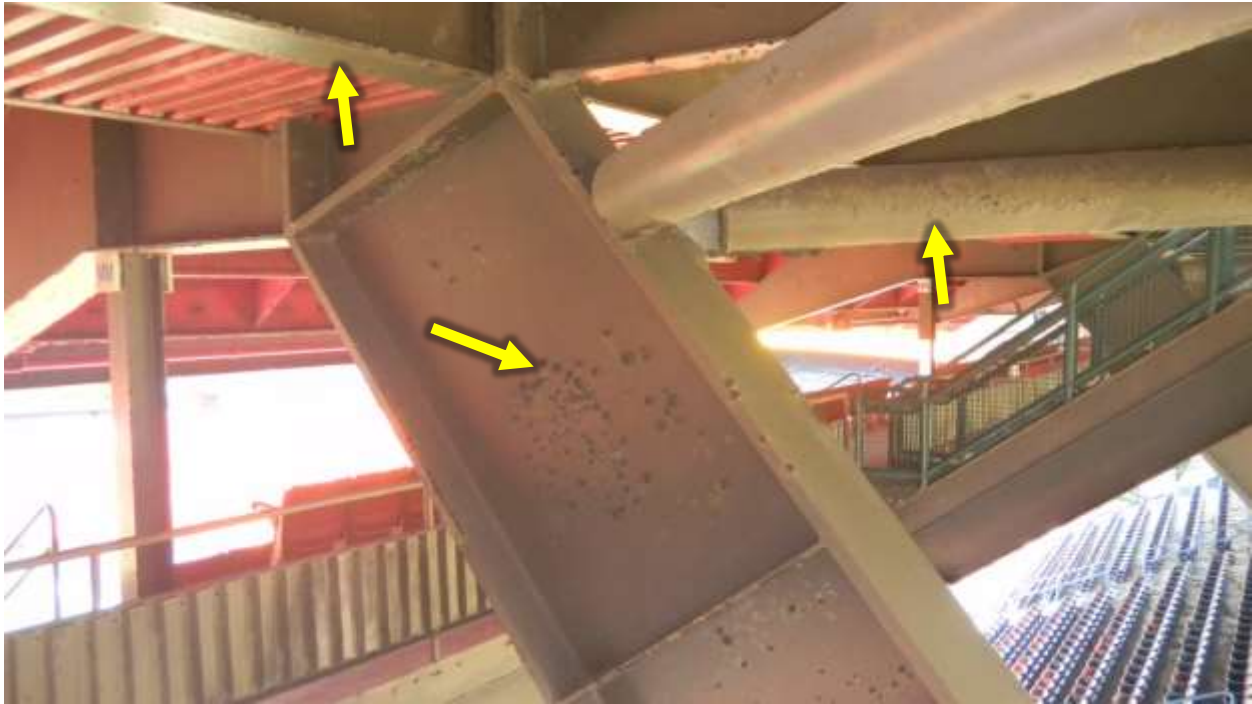
- Condition State 2 (CS2) – Visual signs of localized coating failure with only minor surface corrosion on steel members (Figure 9) or paint loss with corrosion observed or corrosion likely on the visible surfaces of the sub-decking hat channels or the decking itself. Section loss is assumed to not be appreciable. Health and safety implications of CS2 members include the eventual progression of observed deterioration into Condition State 3, and the potential for corrosion products and debonded coatings to displace from the surface of the member or the decking, becoming a nuisance and a relatively minor safety concern, to a lesser degree than for members or decking classified as Condition State 3.

*Figure 9. Example of structural steel member classified as Condition State 2*

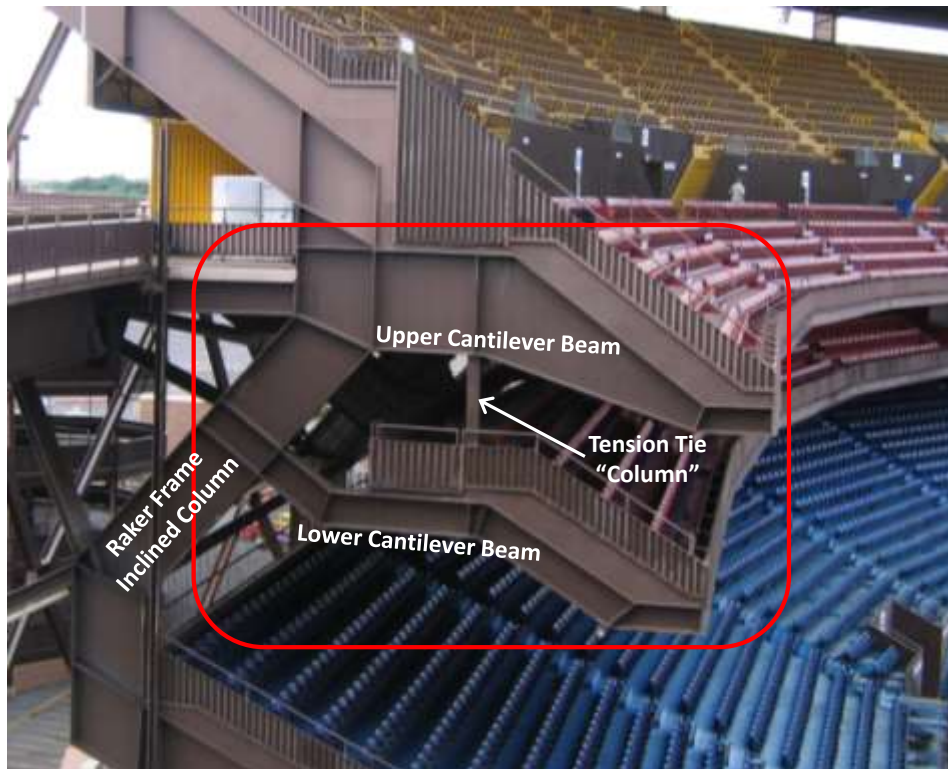
At several end raker frame locations, severe corrosion losses (CS3 and CS4) have been visually observed in the top flange of the deep raker beam supporting the Red seating level (Figure 16). Severe corrosion losses have also been observed in the top flange of the raker beam supporting the Brown seating level. There are a total of twelve end raker frames at the stadium, resulting in a total of twenty-four weather steel raker beams that potentially exhibit notable corrosion losses. There are similar cantilevered assemblies at the interior raker frames, but the beams of the interior cantilever assemblies do not exhibit corrosion to the same extent as do the beams on the end frame cantilever assemblies.

It appears that, over the years, rainwater has entered into operable access hatches in the floor deck at the ends of the cross aisles servicing the Red and Brown seating areas. The access hatches are located immediately above the subject raker beams in the end raker frames. The rainwater appears to have leaked directly onto the top flanges of the raker beams, resulting in notable corrosion to the top flanges of the raker beams due to relatively persistent wetness.

*Figure 15. View of a typical end-bay raker frame, with cantilevered raker assembly highlighted by red box. Annotations indicate various features of the cantilevered assembly.*

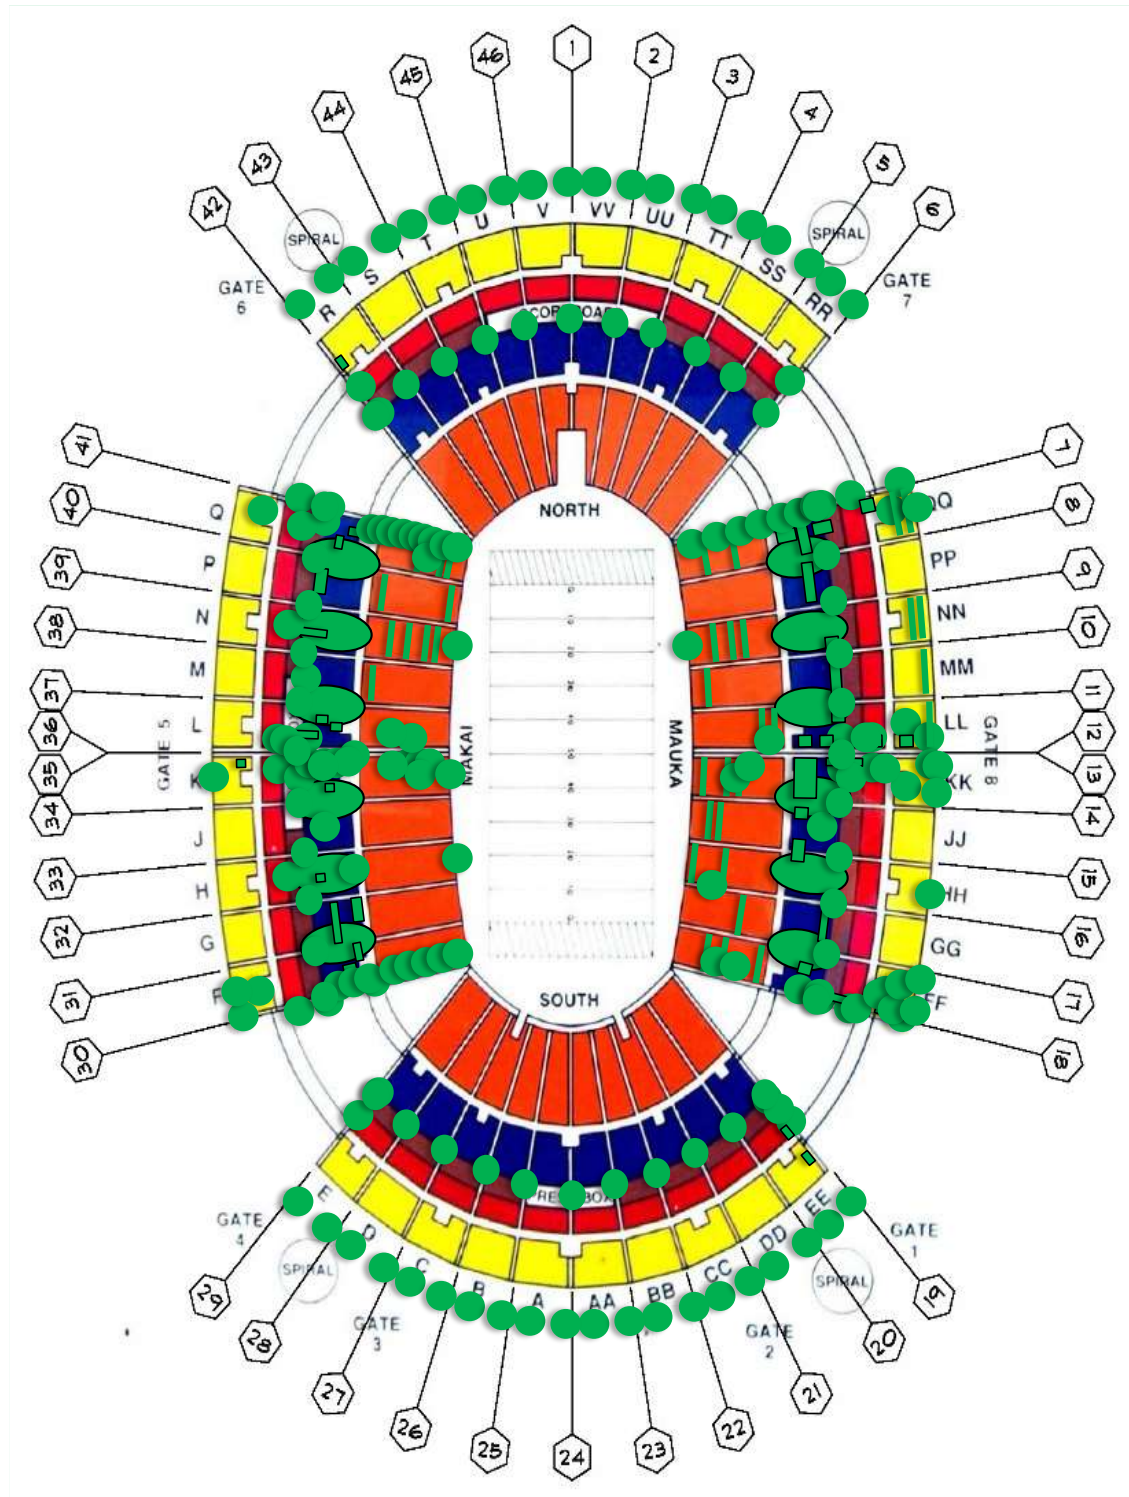
Figure 26. Graphical depiction of locations of recommended repairs: 2018 corrosion assessment

The locations where structural steel members have been categorized as CS3 and CS4 are graphically summarized in Figure 25 for the 2016 survey, and in Figure 26 for the 2018 survey; these figures also include locations where metal decking panels and seating plate rows are categorized as either CS3 or CS4, but do not include locations where fiberglass angles were identified as potential falling hazards.

The findings of the 2018 survey indicate that approximately 85 panels of the lightweight floor slab decking are presently observed to exhibit severe corrosion (CS3 and CS4). Although lightweight decking was not surveyed in 2016, based on anecdotal reports from stadium staff, the number of maintenance-related concerns involving lightweight decking has generally increased with time in recent years. This is anecdotal evidence that the adverse effects of corrosion at the Aloha Stadium are increasing with time.
