ALOHA STADIUM
Structural and Safety Evaluations:
Weathering Steel and Decking Corrosion Assessment
DAGS Job No. 12-10-0651
99-500 Salt Lake Boulevard
Halawa, Honolulu County, Hawaii

Final Report
December 12, 2018
WJE No. 2014.6720.1

Table 1. Summary of Recommended Repairs - 2018 Assessment

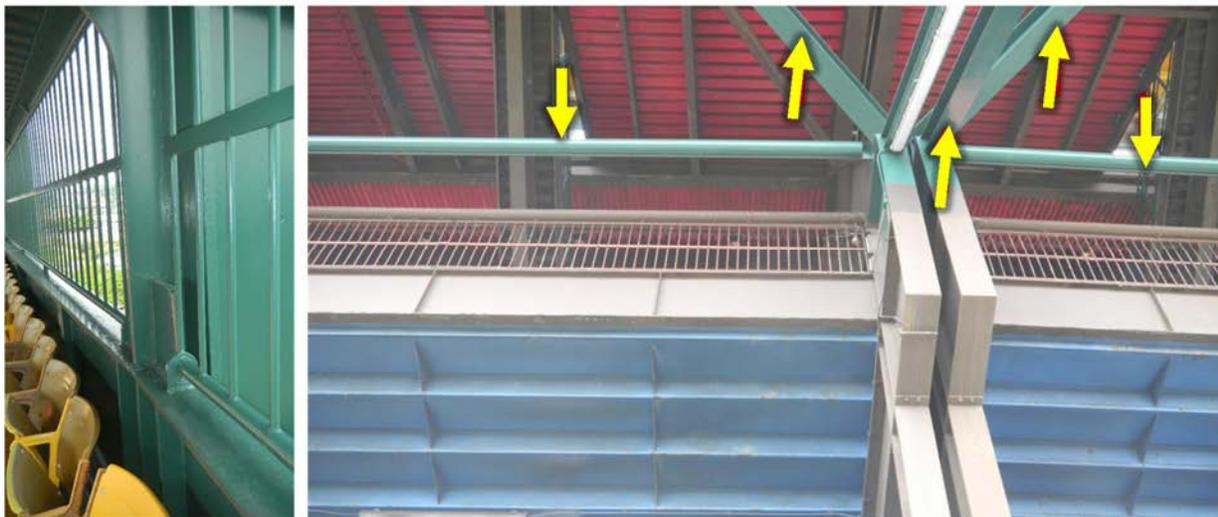
- Condition State 1 (CS1) – No discernable coating failure on steel members (Figure 8) or the visible surfaces of the sub-decking hat channels or the decking itself; therefore, no corrosion is assumed. These members and decking panels pose no known immediate concern for health and safety of occupants of the structure.

Figure 8. Examples of structural steel members classified as Condition State 1

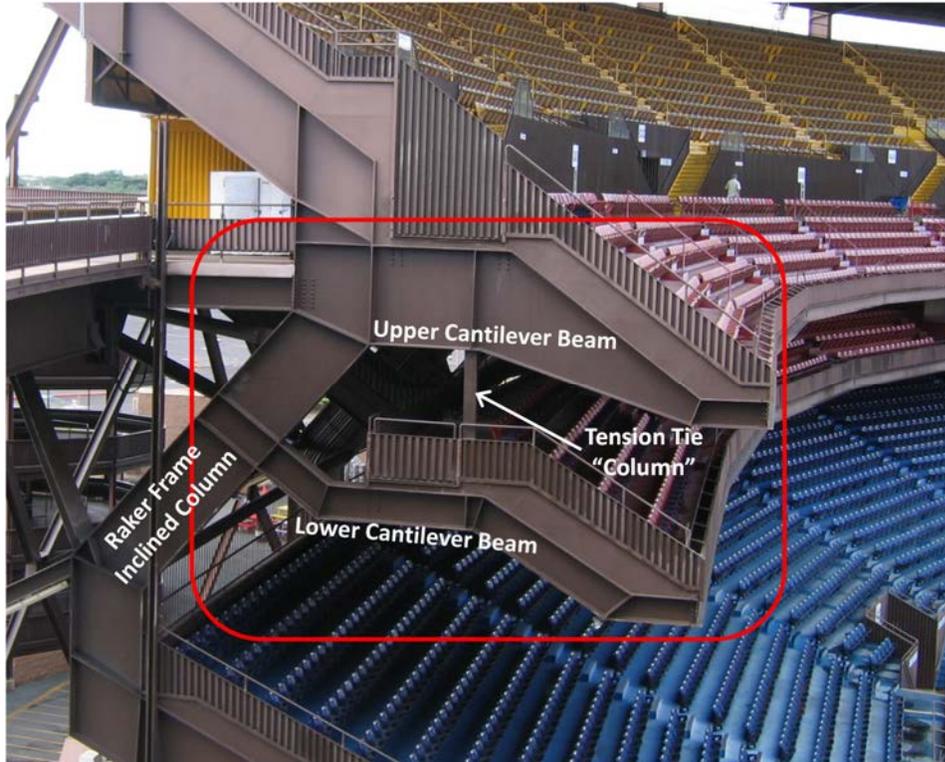
At several end raker frame locations, severe corrosion losses (CS3 and CS4) have been visually observed in the top flange of the deep raker beam supporting the Red seating level (Figure 16). Severe corrosion losses have also been observed in the top flange of the raker beam supporting the Brown seating level. There are a total of twelve end raker frames at the stadium, resulting in a total of twenty-four weather steel raker beams that potentially exhibit notable corrosion losses. There are similar cantilevered assemblies at the interior raker frames, but the beams of the interior cantilever assemblies do not exhibit corrosion to the same extent as do the beams on the end frame cantilever assemblies.

It appears that, over the years, rainwater has entered into operable access hatches in the floor deck at the ends of the cross aisles servicing the Red and Brown seating areas. The access hatches are located immediately above the subject raker beams in the end raker frames. The rainwater appears to have leaked directly onto the top flanges of the raker beams, resulting in notable corrosion to the top flanges of the raker beams due to relatively persistent wetness.

Figure 15. View of a typical end-bay raker frame, with cantilevered raker assembly highlighted by red box. Annotations indicate various features of the cantilevered assembly.

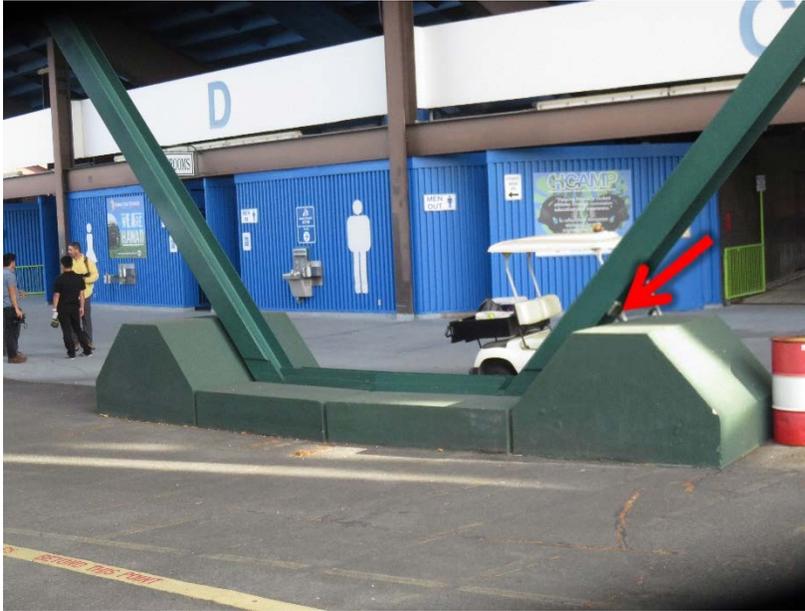
During our August 2018 corrosion survey field activities, along with follow-up visual observation of these braces during September and November 2018, WJE observed severe corrosion losses (CS3 and CS4) in almost every brace, at the bottom end connections in the vicinity of the concrete barrier, where the structural steel brace connects to the reinforced concrete substructure of the seating stand. A representative location classified as CS4 is shown in Figure 18; a total of four braces were categorized as CS4. The locations on the braces where noted corrosion losses occurred are locations where, due to physical interference with the concrete barriers, it is difficult to apply protective coatings to the weathering steel brace member; these locations also are configured in a manner that tends to retain water and debris. As a result, despite having been re-coated within the past 10 years, corrosion of the weathering steel member is apparently on-going at a relatively accelerated rate at these locations because the protective coatings are locally failing, presumably due to inadequate application combined with persistent wetness due to retained water and debris.

Because of the severity of the observed corrosion losses (CS3 and CS4), which included complete loss of section through the entire thickness of the web or the flange of some of the brace members, six brace members in the endzone seating sections of the stadium were selected for further assessment in the field through physical measurements that estimated the extent of member cross-section lost due to corrosion. The field-measured section losses were used to estimate the remaining structural capacity of the as-corroded brace members, specifically at the location where the brace member penetrates into the concrete barrier. Structural demands, determined using current building code requirements, were then calculated for these members and subsequently compared to remaining structural capacities; the results of such comparisons are typically expressed numerically in terms of demand-to-capacity ratios.

Based on our field measurements and subsequent structural analyses, we find that the current structural capacities of the as-corroded brace members are such that demand-to-capacity ratios are only slightly below 1.0. This means that the remaining structural capacity of the as-corroded brace member only marginally satisfies the structural strength requirements of the current building code.

Figure 17. Representative concrete barrier at base of structural steel braces that make up the diagonal bracing frame at the rear of the endzone seating stands (South endzone shown). The red arrow indicates viewing position for the photo of Figure 18.

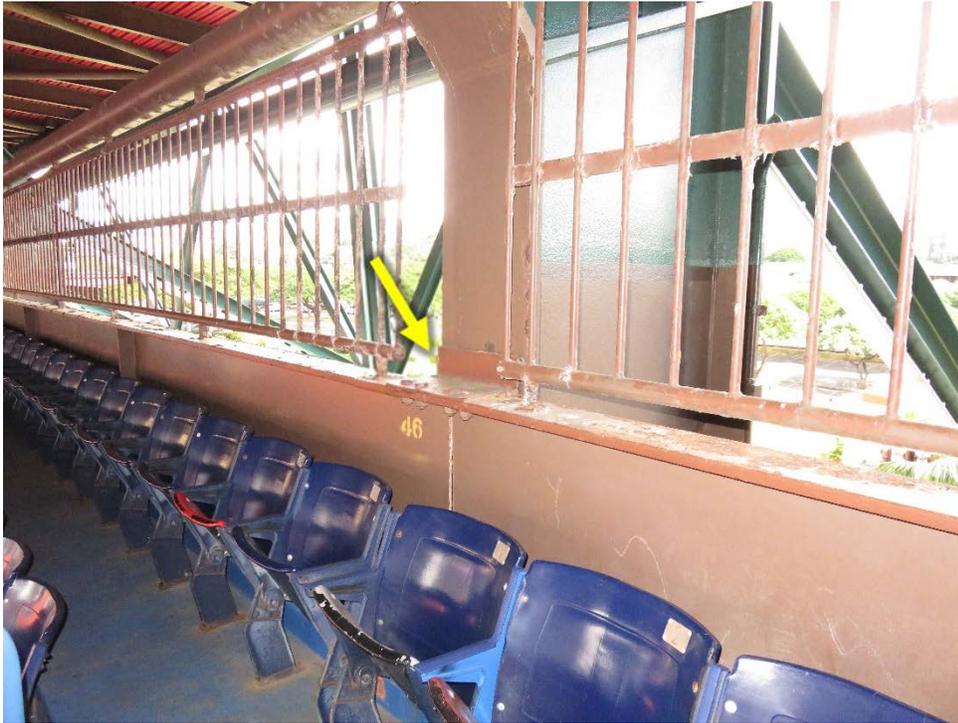
Water becomes entrapped between the vertical leg of the angle and flange of the raker column. The entrapped moisture is causing corrosion on the connection angle and the flange of the raker column. The expansion of the corrosion products between the connection angle and the flange of the raker column applies a prying force to the connecting pieces that has resulted in partial or complete failure of the weld between the connection angle and the raker column flange at many of these connections (Figure 20 and Figure 21). Continued corrosion at these connections will result in further cracking of the affected welds. At the time of our survey, the welds have failed to various degrees at approximately 75 percent of these angle connections.

Figure 19. Typical location of problematic Blue seating section connection between girder and raker frame column.

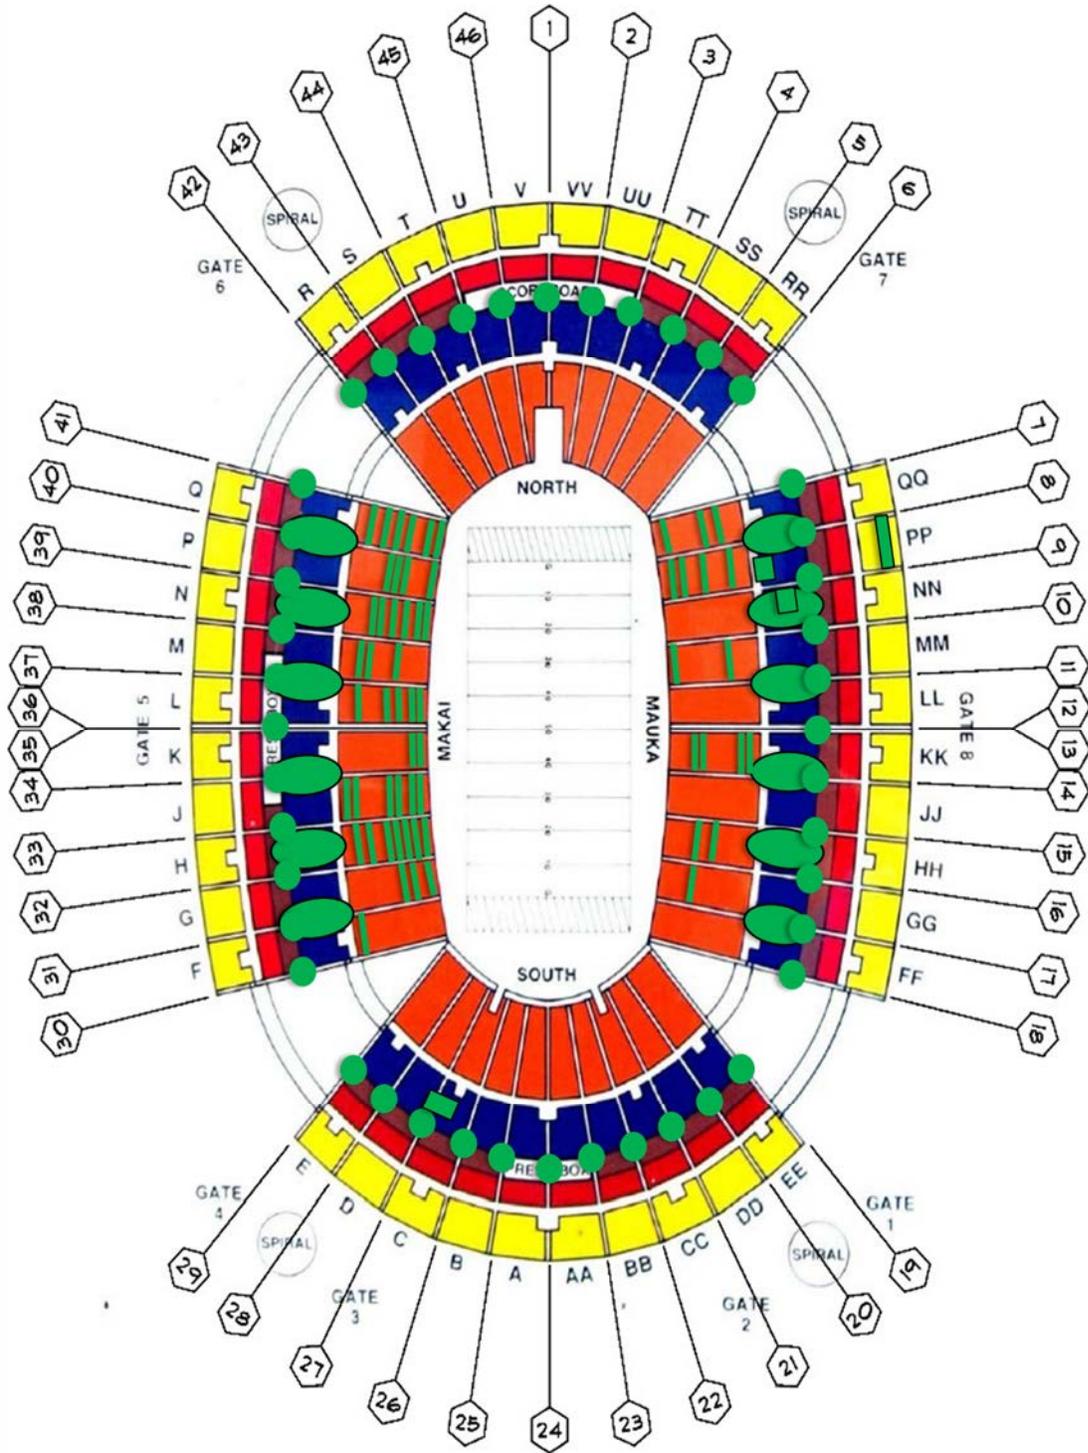
The locations where structural steel members have been categorized as CS3 and CS4 are graphically summarized in Figure 25 for the 2016 survey, and in Figure 26 for the 2018 survey; these figures also include locations where metal decking panels and seating plate rows are categorized as either CS3 or CS4, but do not include locations where fiberglass angles were identified as potential falling hazards.

The findings of the 2018 survey indicate that approximately 200 weathering steel members are presently categorized as either CS3 or CS4, which means that these members exhibit severe corrosion. In our 2016 survey, approximately 50 weathering steel members were categorized as either CS3 or CS4. Over the course of approximately two years, the cumulative number of steel framing members categorized as either CS3 or CS4 has *increased* by 200 percent. This is quantifiable evidence that the adverse effects of corrosion at the Aloha Stadium are increasing with time.

Figure 25. Graphical depiction of locations of recommended repairs: 2016 corrosion assessment

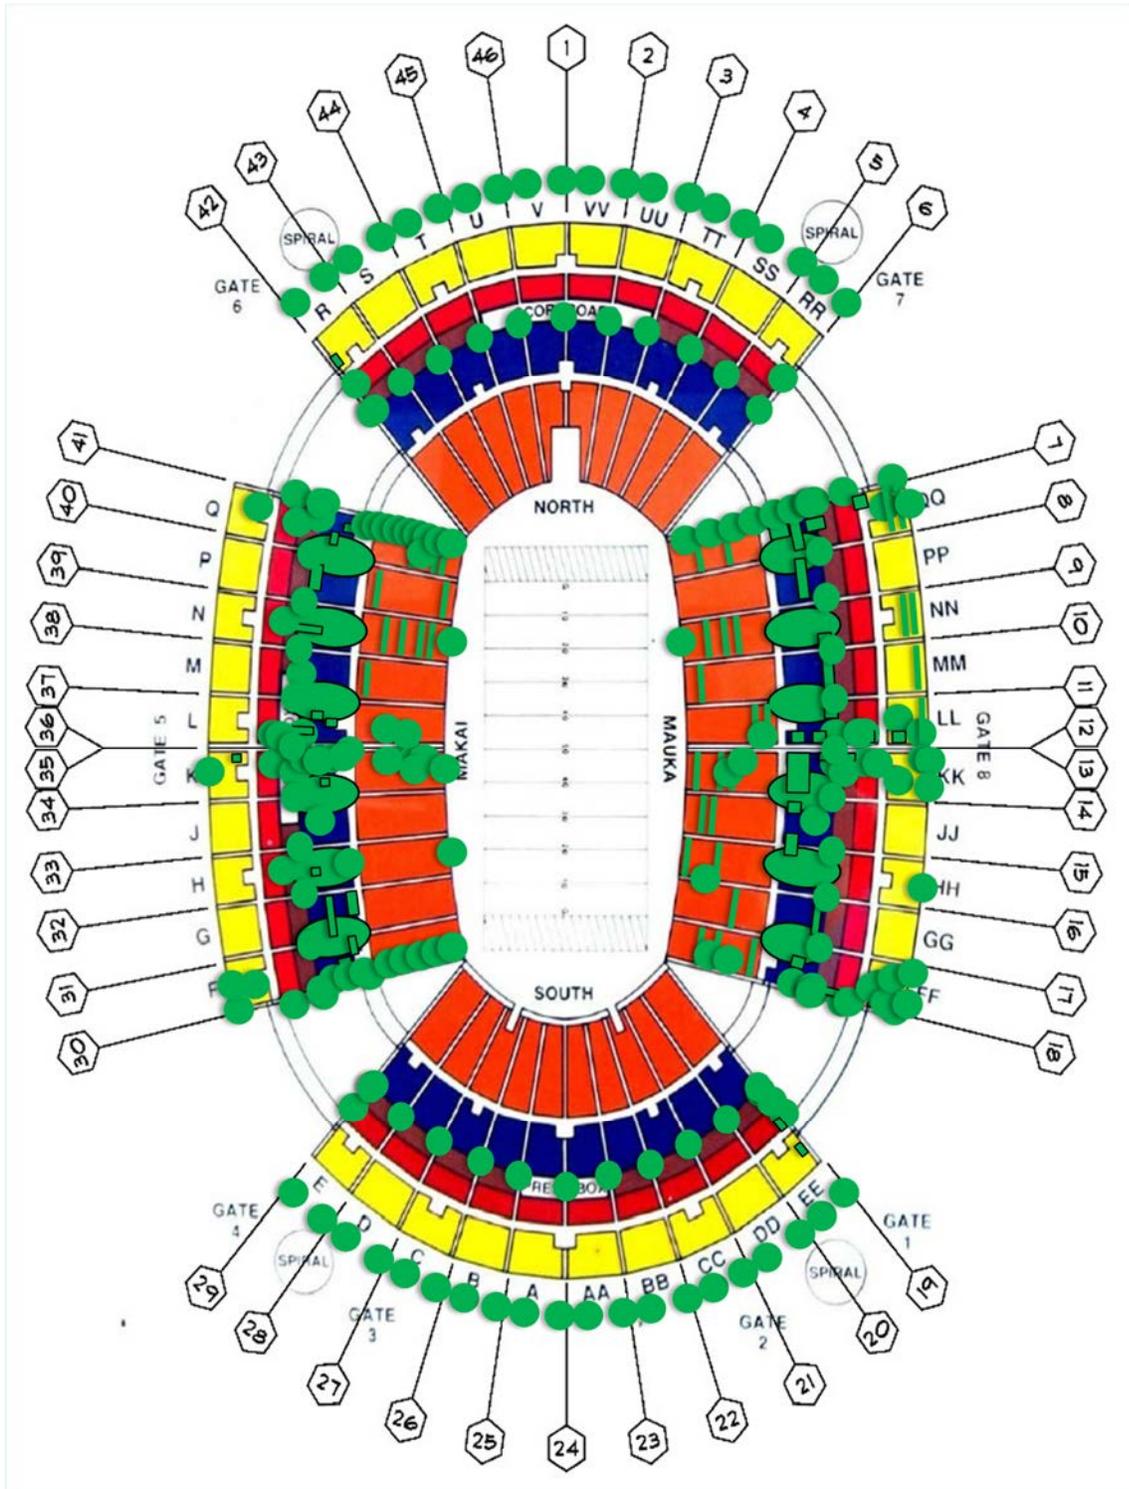
The findings of the 2018 survey indicate that approximately 85 panels of the lightweight floor slab decking are presently observed to exhibit severe corrosion (CS3 and CS4). Although lightweight decking was not surveyed in 2016, based on anecdotal reports from stadium staff, the number of maintenance-related concerns involving lightweight decking has generally increased with time in recent years. This is anecdotal evidence that the adverse effects of corrosion at the Aloha Stadium are increasing with time.

Figure 26. Graphical depiction of locations of recommended repairs: 2018 corrosion assessment
